# PROPERTY INSPECTION REPORT

*Student  
Housing*

**20 Sewells Walk**

**Friday, 13 March 2026**

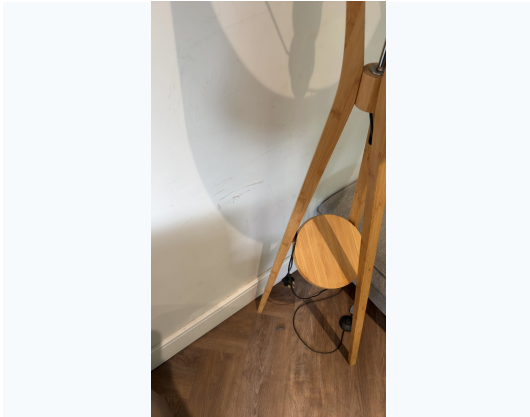
DEFECT 1 | Living Room

Marked walls

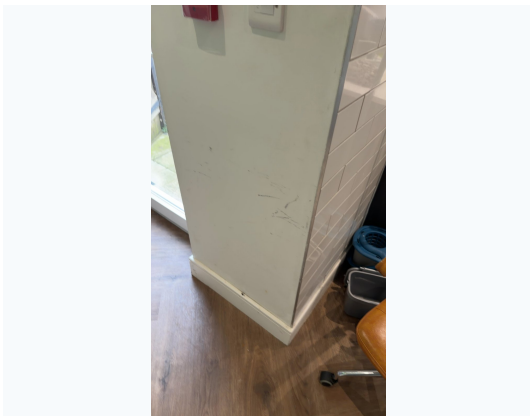
DEFECT 2 | Living Room

Marked walls

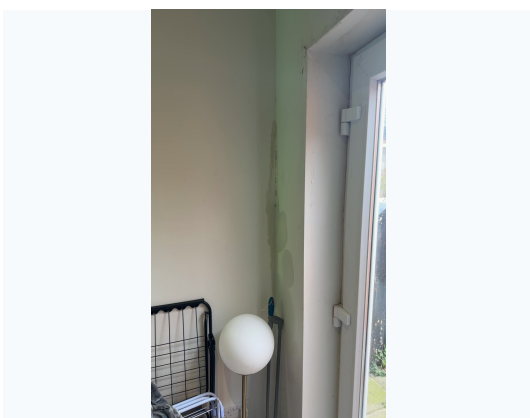
DEFECT 3 | Living Room

Possible damp / water ingress

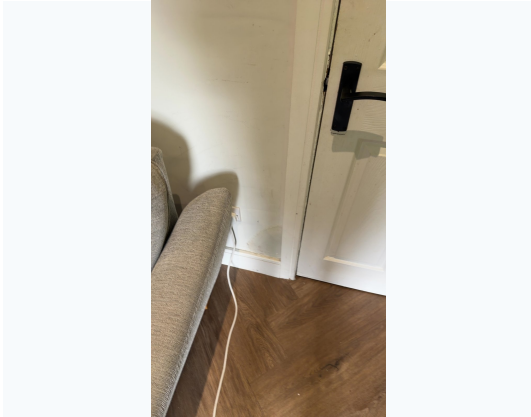
DEFECT 4 | Living Room

Marks to walls

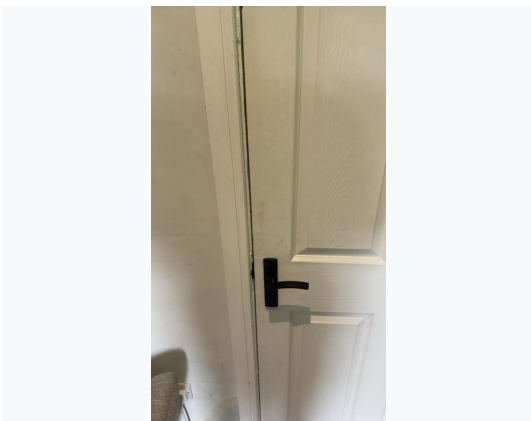
DEFECT 5 | Living Room

Marks to door

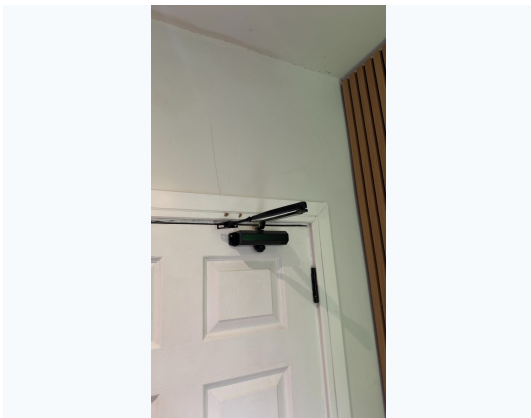
DEFECT 6 | Living Room

Door closer has been removed.

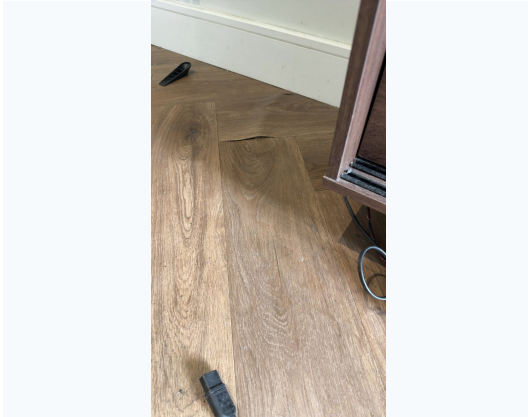
DEFECT 7 | Living Room

Floor is lifting. Looks like le it's got wet some how

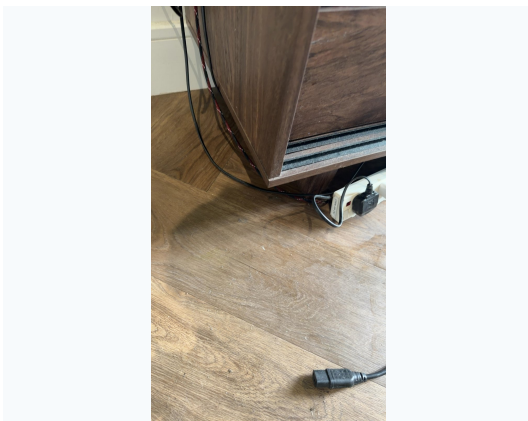
DEFECT 8 | Living Room

Marks on floor from water.

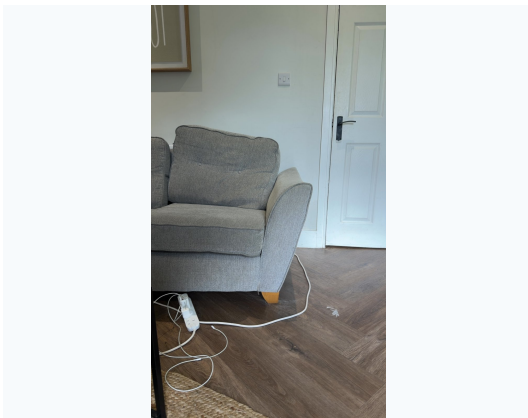
DEFECT 9 | Living Room

Potential damage to sofa arm

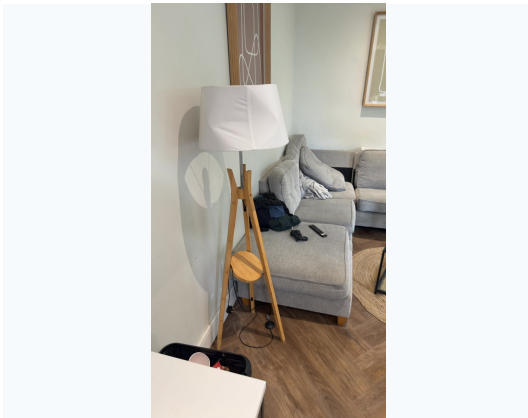
DEFECT 10 | Living Room

Lamp has been damaged.

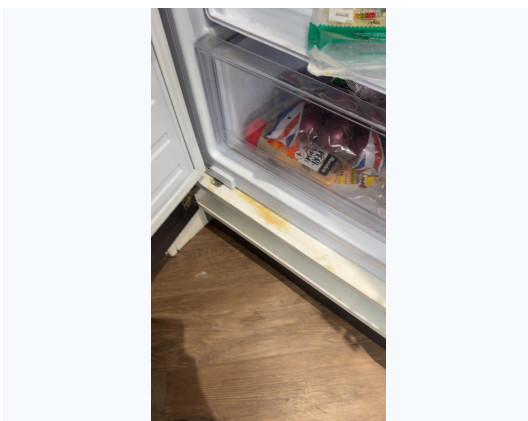
DEFECT 11 | Kitchen

Needs cleaning

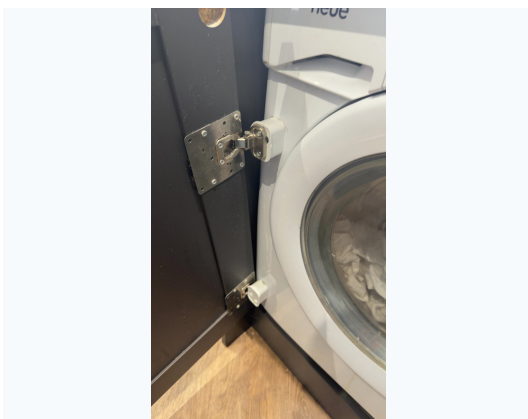
DEFECT 12 | Kitchen

Door hinge is broken

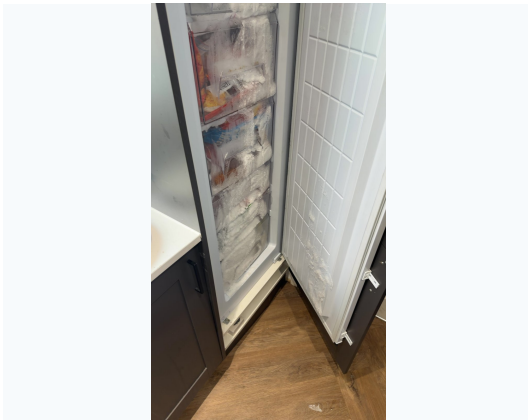
DEFECT 13 | Kitchen

Needs defrosting

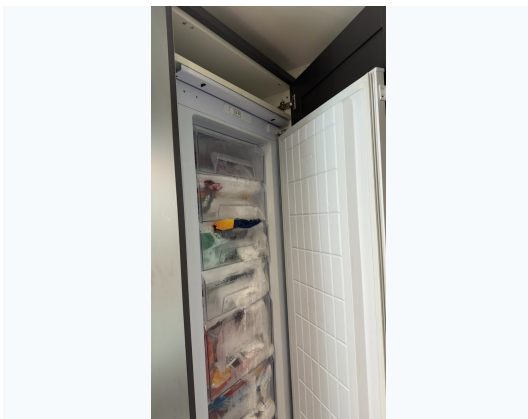
DEFECT 14 | Kitchen

Needs defrosting

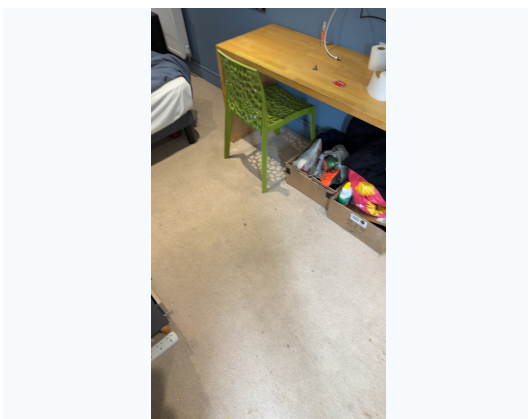
DEFECT 15 | Bedroom 2

Floor is heavily worn

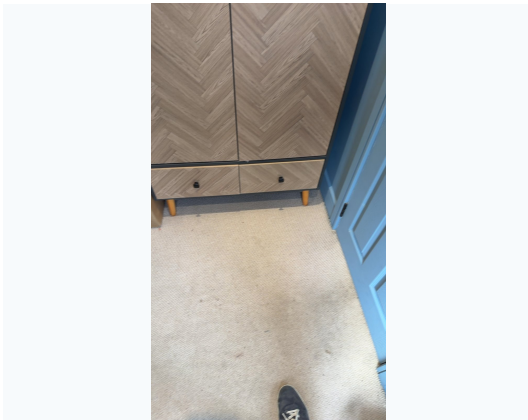
DEFECT 16 | Bedroom 2

Carpet needs cleaning

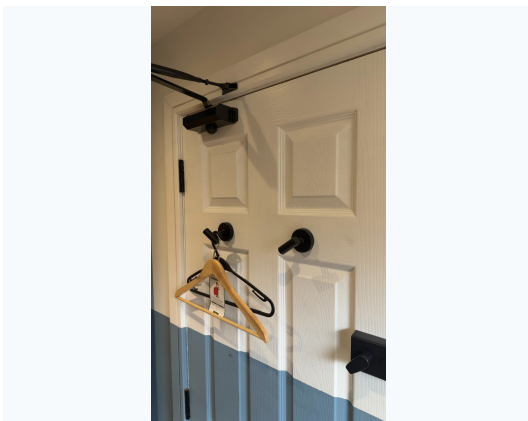
DEFECT 17 | Bedroom 2

Hooks are broken and need repair

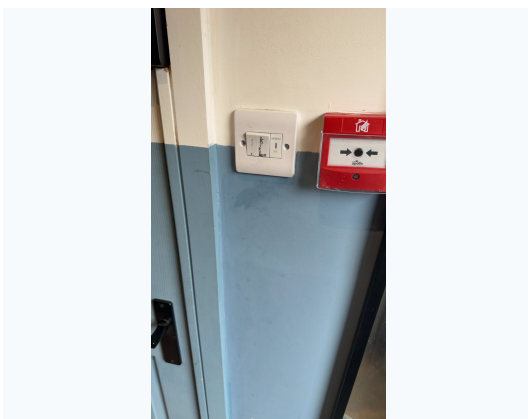
DEFECT 18 | Bedroom 2

Marks to walls

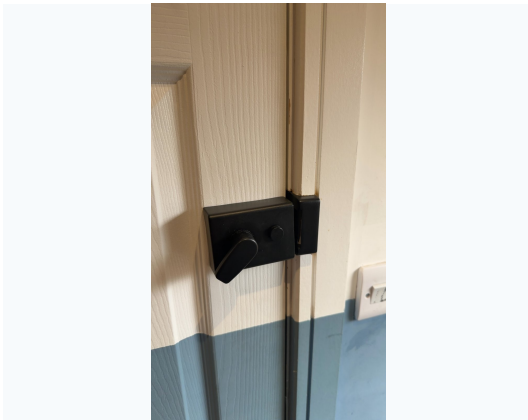
DEFECT 19 | Bedroom 2

Needs tightening

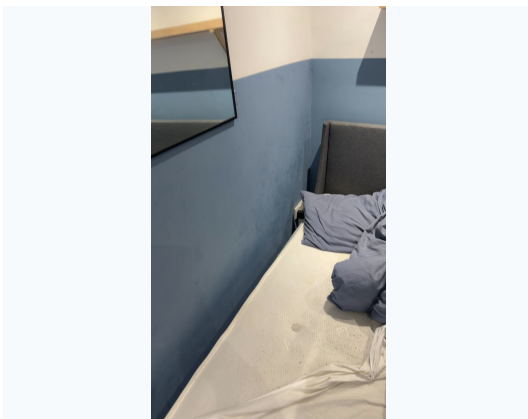
DEFECT 20 | Bedroom 2

Lots of marks to paintwork. Will require redecoration

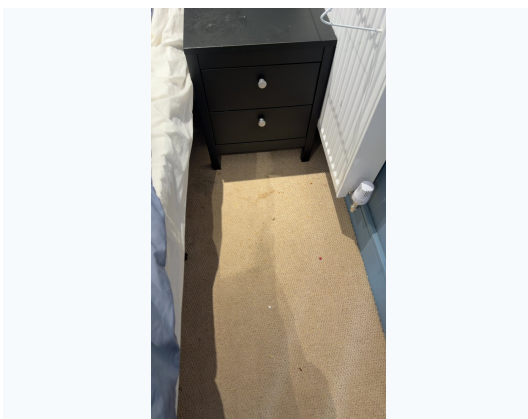
DEFECT 21 | Bedroom 2

Marks and stains to carpets

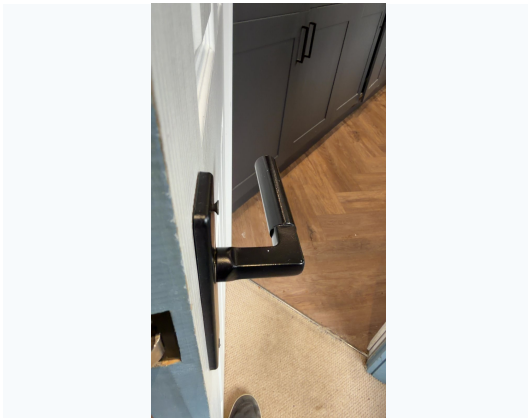
DEFECT 22 | Bedroom 2

Door handle needs tightening

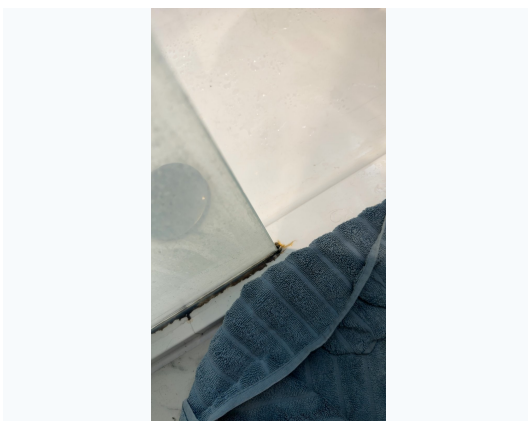
DEFECT 23 | Bedroom 3

Needs cleaning

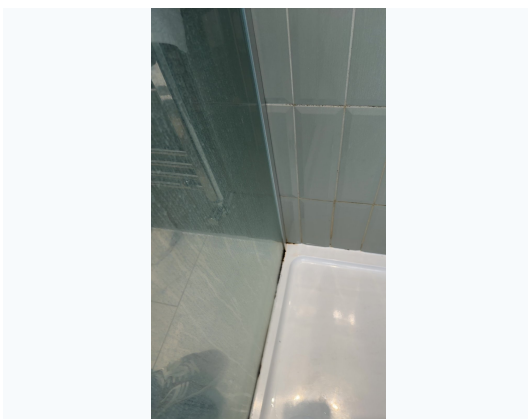
DEFECT 24 | Bedroom 3

Significant mould growth is present on the silicone sealant along the base of the shower screen and where the screen meets the tiled wall. The shower screen itself is heavily soiled with visible watermarks and grime.

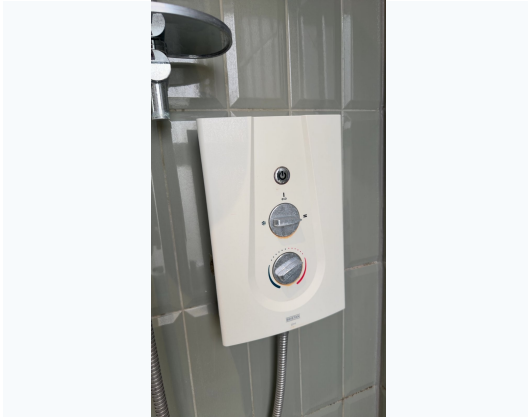
DEFECT 25 | Bedroom 3

Dust and debris accumulation observed on the surface of the Bristan electric shower unit and surrounding wall tiles, indicating a need for routine cleaning.

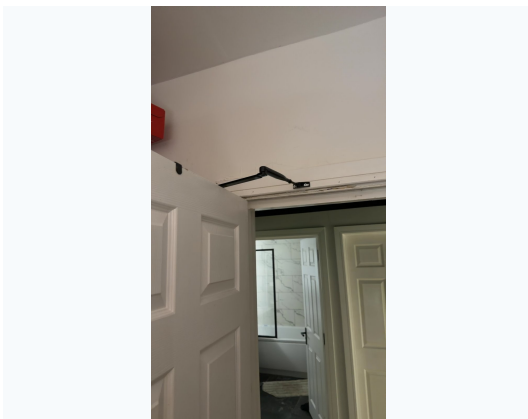
DEFECT 26 | Bedroom 4

Door slams

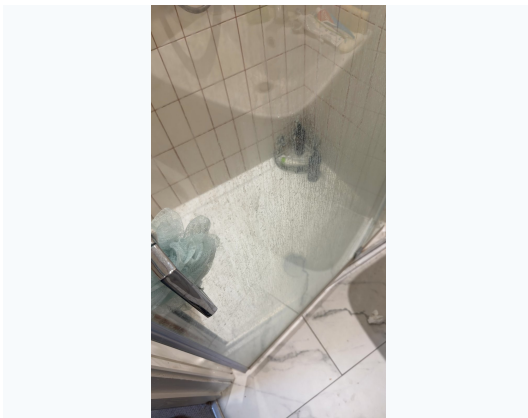
DEFECT 27 | Bedroom 4

The shower screen exhibits significant limescale accumulation and water staining across its full glazed area, diminishing its transparency and aesthetic appearance.

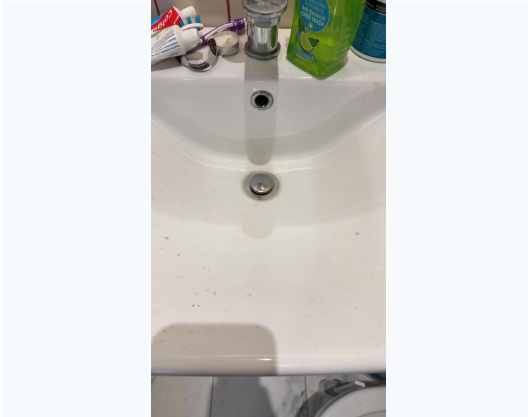
DEFECT 28 | Bedroom 4

Needs cleaning

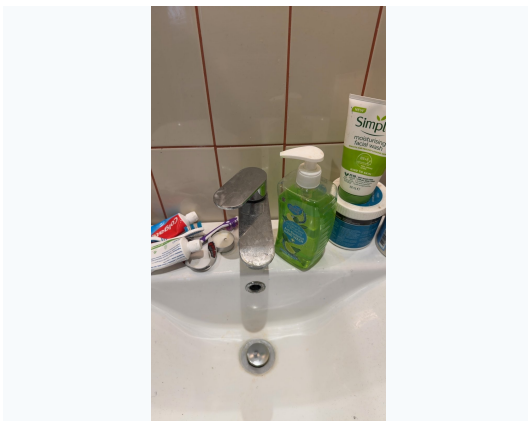
DEFECT 29 | Bedroom 4

Needs cleaning

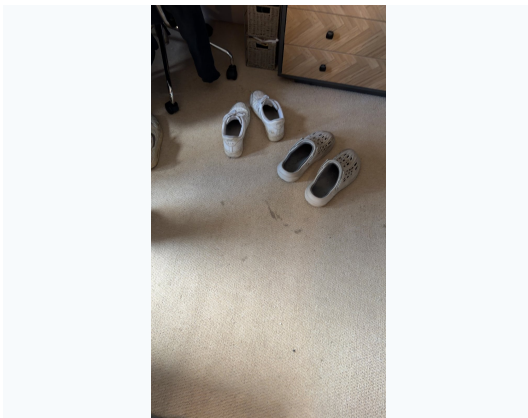
DEFECT 30 | Bedroom 4

Multiple dark stains visible on the carpet in the mid-ground.

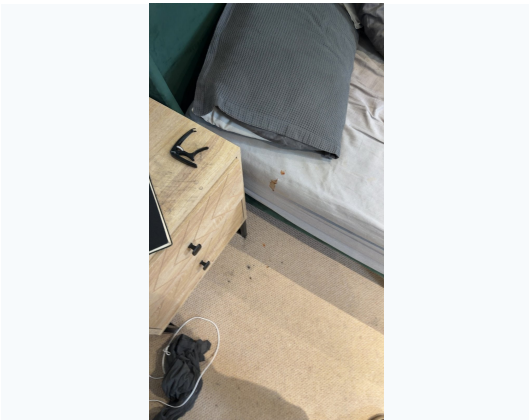
**DEFECT 31 | Bedroom 5** ● General Observation

Minor burn marks are noted on the carpet between the bedside cabinet and the bed, consistent with carelessly discarded smoking materials.

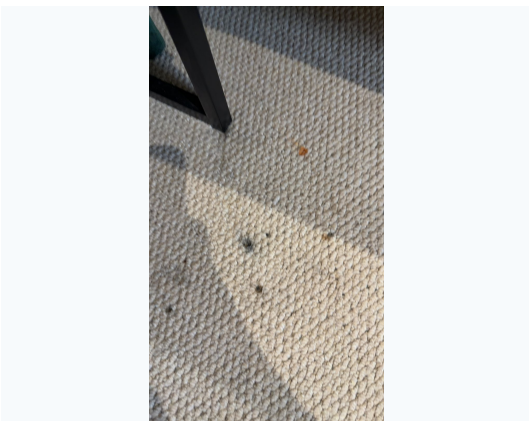
**DEFECT 32 | Bedroom 5** ● General Observation

Multiple burn marks are present on the carpet, varying in size, as observed in the area visible in the photograph.

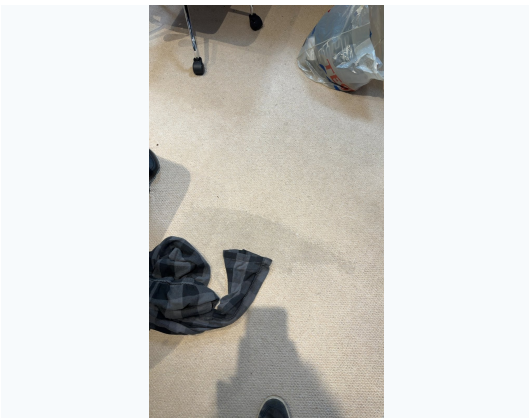
**DEFECT 33 | Bedroom 5** ● General Observation

Localised staining observed on the carpeted floor surface in the central area.

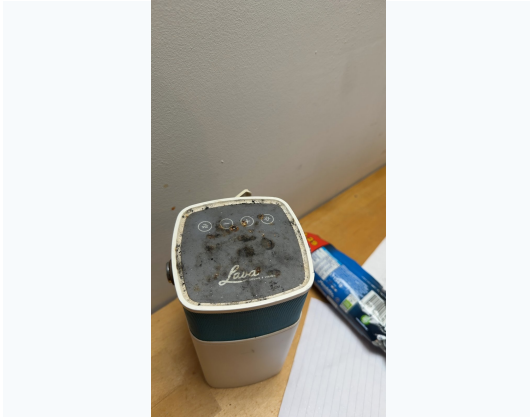
DEFECT 34 | Bedroom 5

Evidence of ash and cigarette debris noted on the surface of the electronic device, suggesting use as an ashtray, which indicates smoking has occurred within the property. Further examination may be required to ascertain the extent of smoking residue on

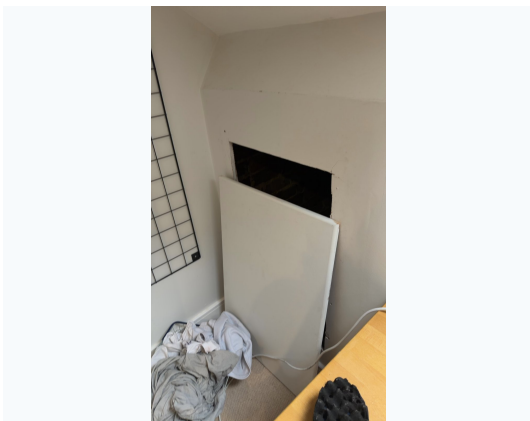
DEFECT 35 | Bedroom 5

Panel needs re-fitting

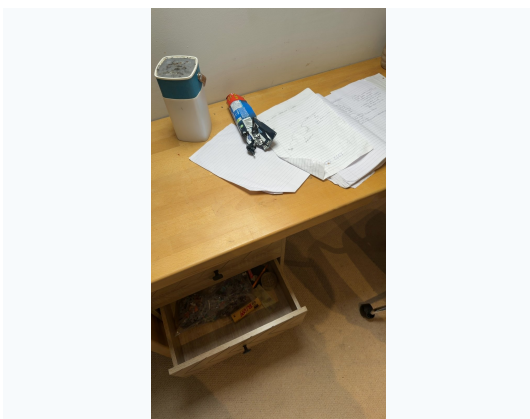
DEFECT 36 | Bedroom 5

Needs cleaning.

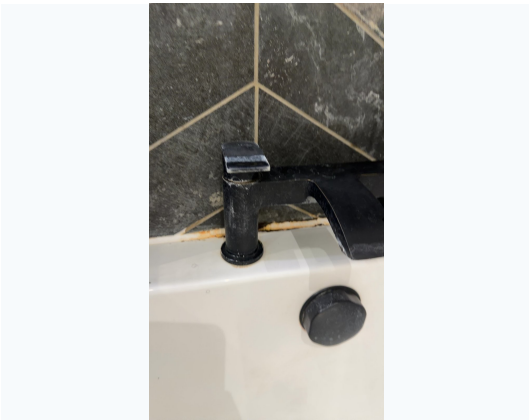
**DEFECT 37 | Bathroom 1** ● Condition Noted

The bath tap and surrounding sealant exhibit heavy limescale and water staining.

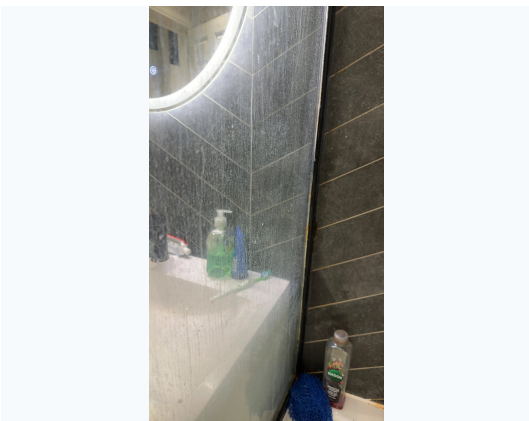
**DEFECT 38 | Bathroom 1** ● Condition Noted

Extensive water staining is apparent on the glass shower screen and adjacent wall tiles, indicating hard water residue buildup.

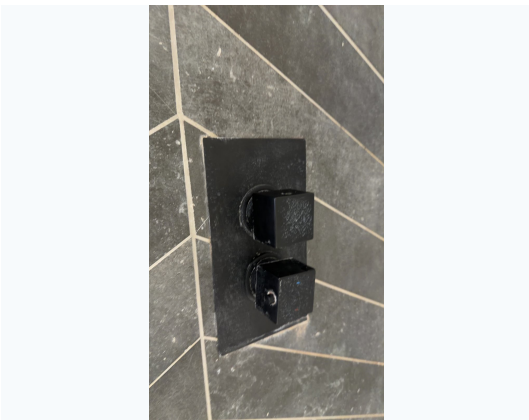
**DEFECT 39 | Bathroom 1** ● General Observation

Heavy limescale and water staining are present on the black shower mixer plate and controls.

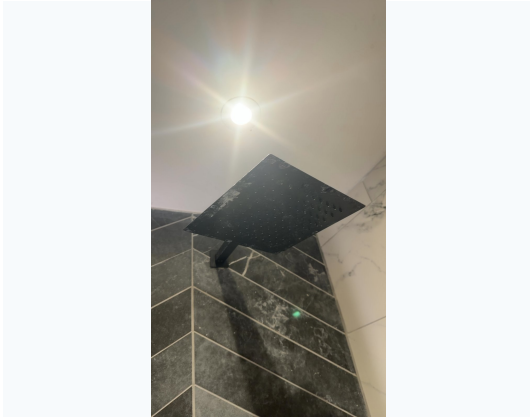
DEFECT 40 | Bathroom 1

The showerhead is heavily stained with visible limescale and watermarks across its entire surface.

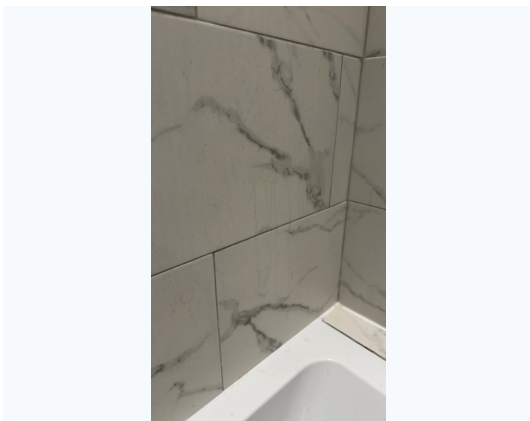
DEFECT 41 | Bathroom 1

Tiled walls above the bath exhibit significant staining and residue, presenting as vertical drip marks and general surface discoloration across multiple tiles.

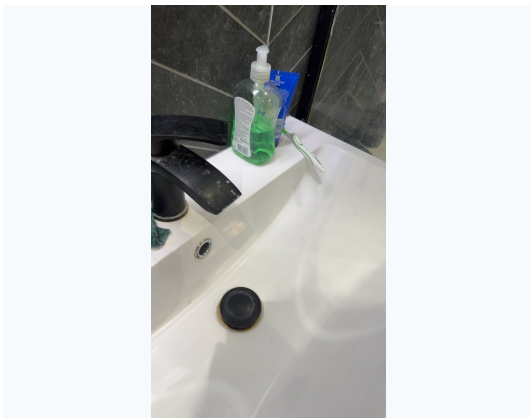
DEFECT 42 | Bathroom 1

The general cleanliness of the sink area is poor. Evidence of limescale and water marking is visible on the tap, alongside residual soap and grime within the basin, indicating a need for cleaning.

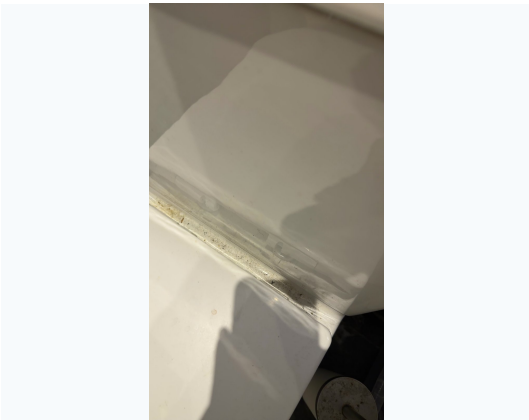
**DEFECT 43 | Bathroom 1** ● Condition Noted

Mould growth and debris are present along the sealant and edges of the shower screen or bath enclosure, indicating a need for cleaning.

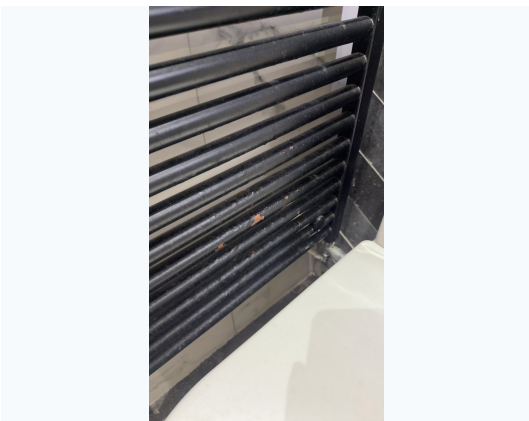
**DEFECT 44 | Bathroom 1** ● Condition Noted

The towel radiator exhibits significant paintwork deterioration, particularly on the lower and central rungs, with multiple areas of coating failure and visible rust spots. This damage is consistent with corrosive exposure, necessitating replacement of the

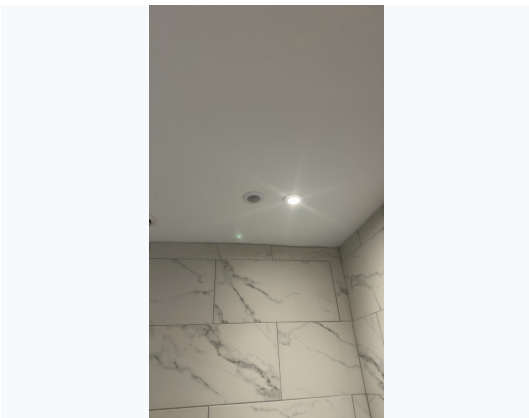
**DEFECT 45 | Bathroom 1** ● Needs Repair

The sensor-activated lighting in the ceiling appears to require calibration, as one recessed light is illuminated while an adjacent identical fixture remains unlit, suggesting an issue with its activation duration or sensitivity.

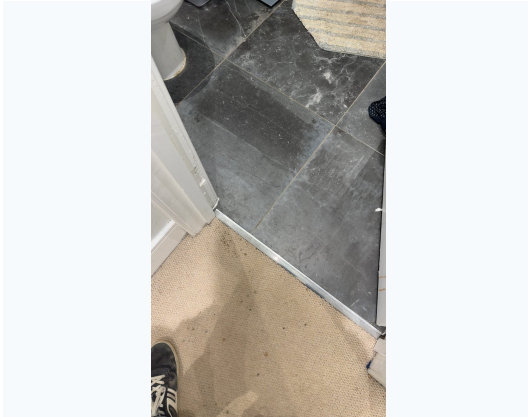
DEFECT 46 | Bathroom 1

Needs sticking down to tiles / carpet as has come loose.

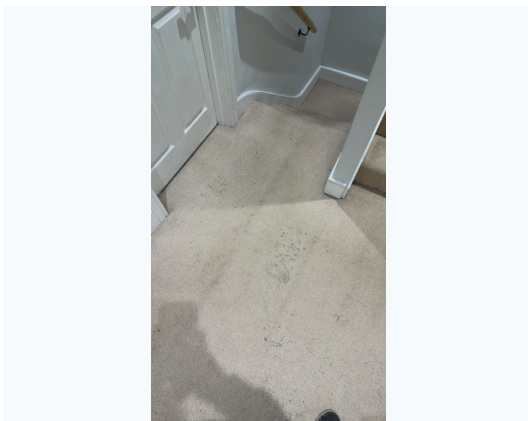
DEFECT 47 | Hallway

Carpets heavily stained

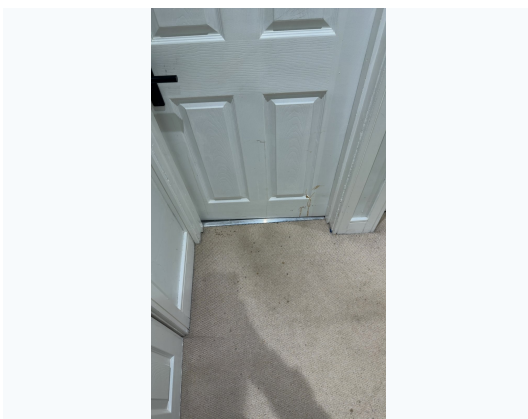
DEFECT 48 | Hallway

Marks and dirt to door

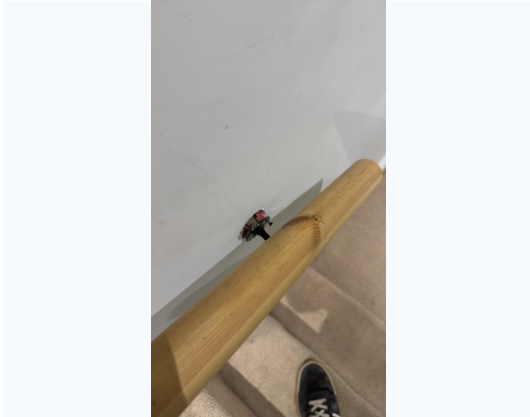
DEFECT 49 | Hallway

The handrail has become detached from the wall, exposing rawlplugs from the mounting point. A visible crack is present in the plasterwork extending horizontally from the mounting point.

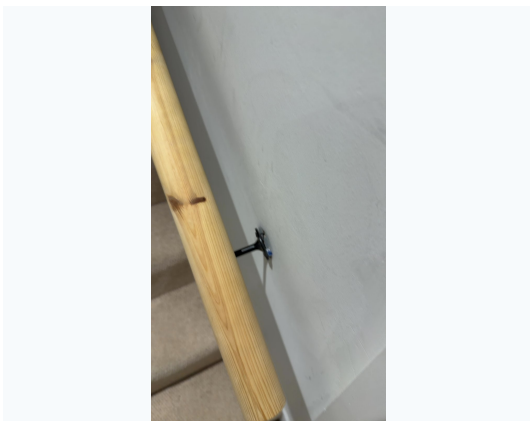
DEFECT 50 | Hallway

The handrail fixing hardware and part of the handrail has become detached from the wall, resulting in a gap between the handrail and the wall surface.

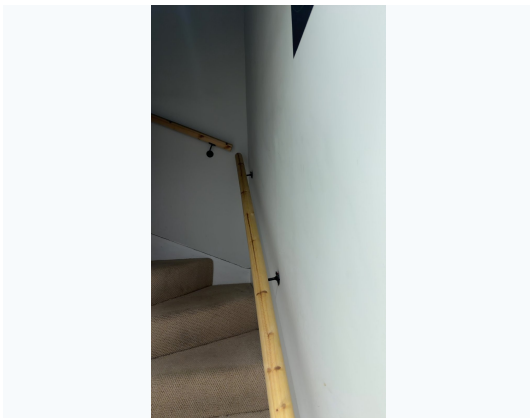
DEFECT 51 | Hallway

The timber handrail has partially detached from the wall at the upper fixing point, displaying a visible gap between the rail and the bracket. The lower handrail section also appears to be loosely fitted, indicating unstable support.

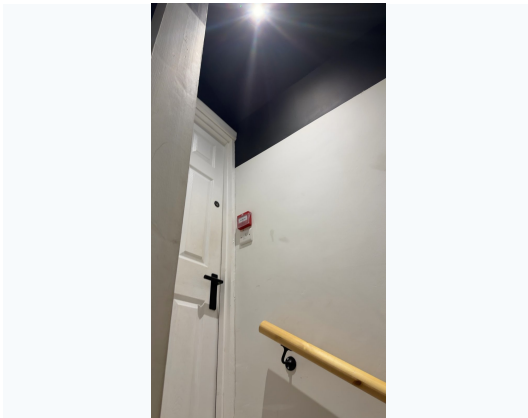
DEFECT 52 | Hallway

A distinct odour is perceivable within the staircase and hallway area, emanating from an unknown source.

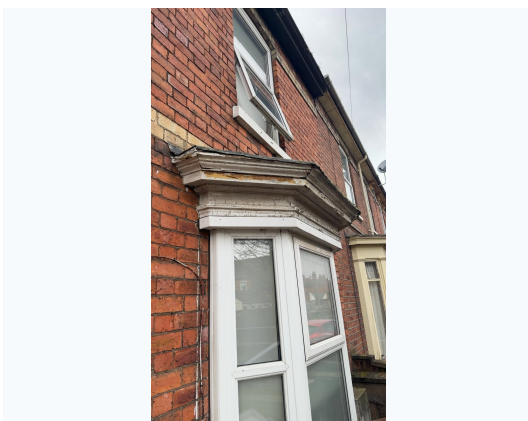
DEFECT 53 | Garden

The bay window fascia and soffit require repainting due to widespread peeling and cracking of the existing paint finish, which is exposing the timber substrate. Discoloration and deterioration of the timber are visible in multiple areas,

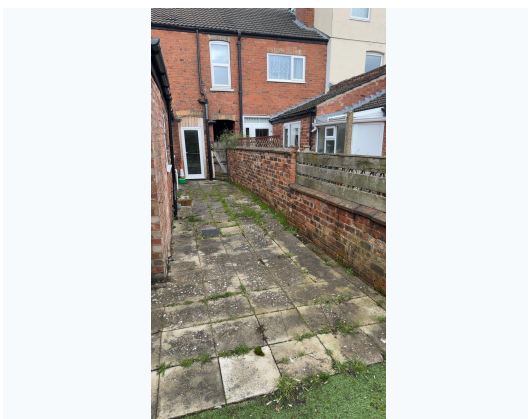
DEFECT 54 | Garden

Weeds and organic growth are present in multiple locations on the paved pathway, particularly within the gaps between paving slabs.

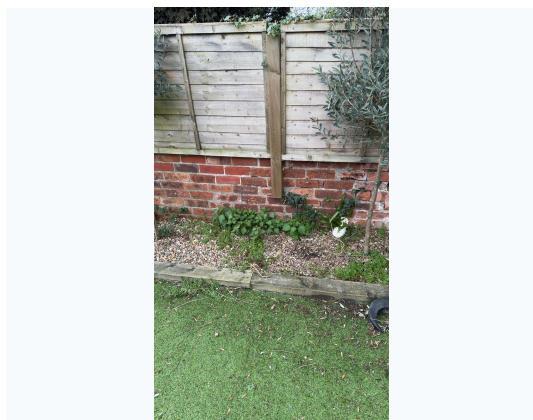
DEFECT 55 | Garden

Plant growth, identified as weeds, is present in the garden border adjacent to the brick wall and timber fencing. These are dispersed throughout the gravelled area.
