# PROPERTY INSPECTION REPORT

*Student  
Housing*

**20 Sewells Walk**

**Friday, 13 March 2026**

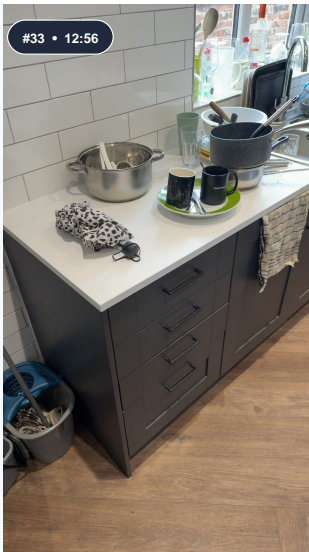
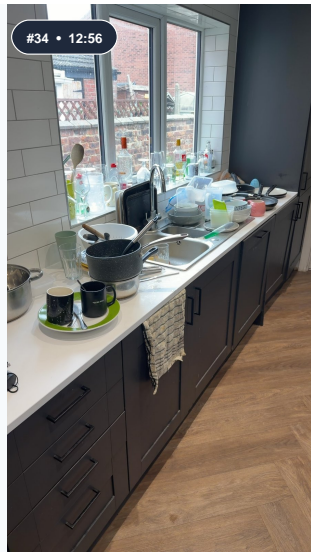
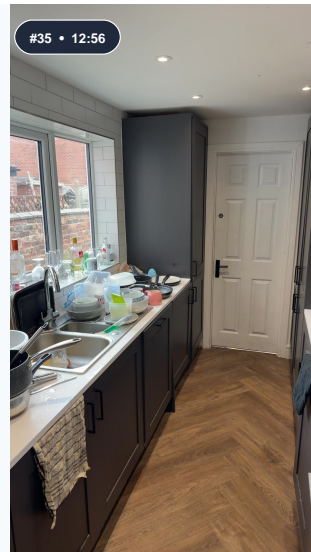
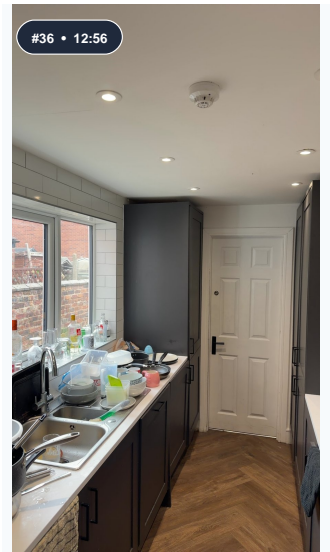
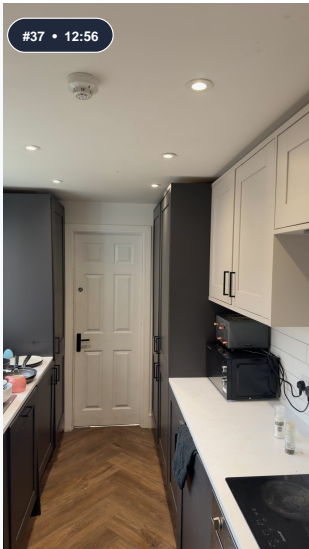
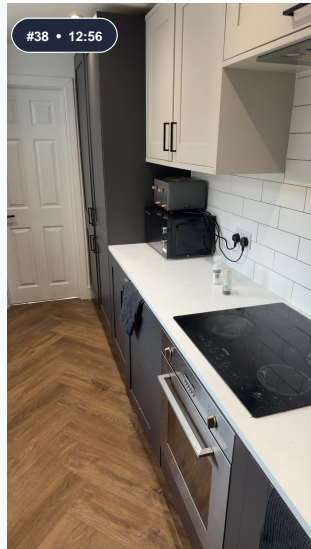
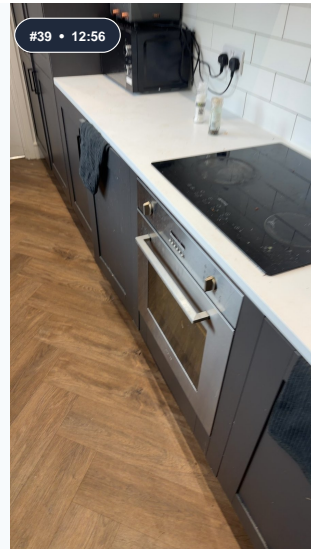
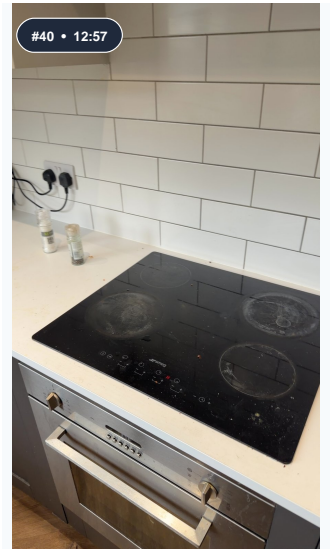
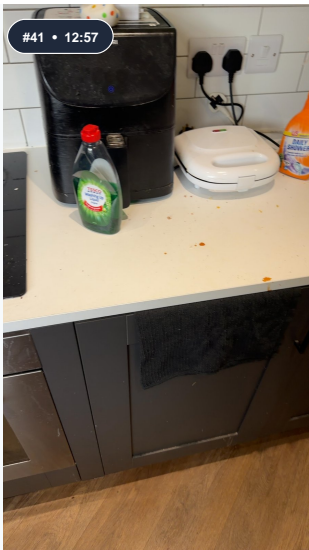
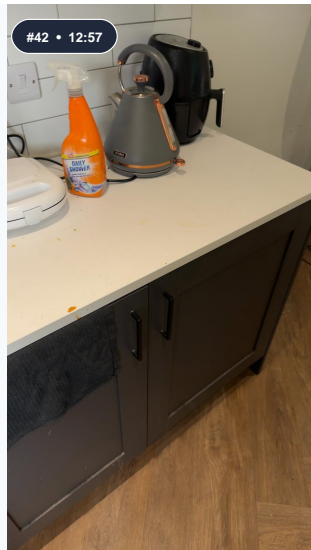
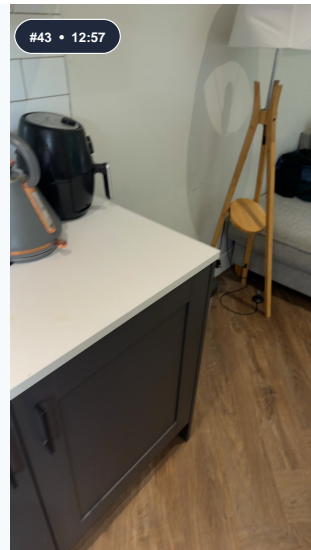
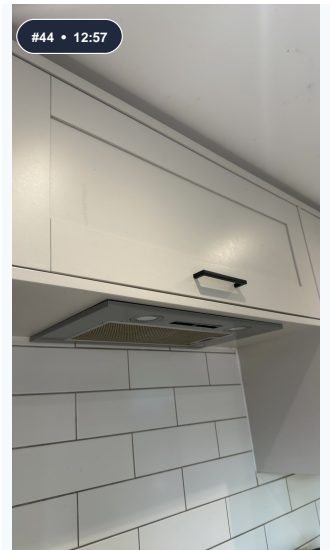
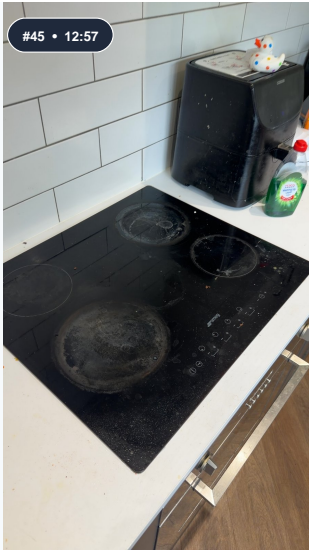
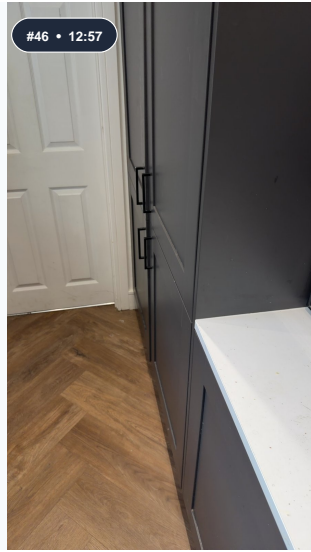
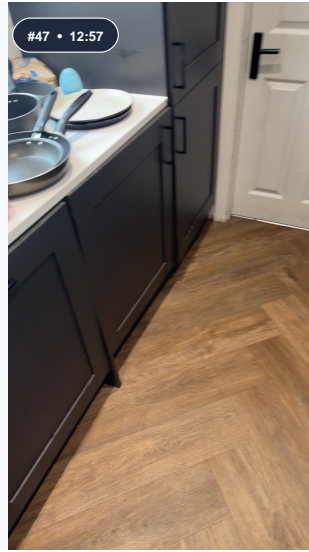
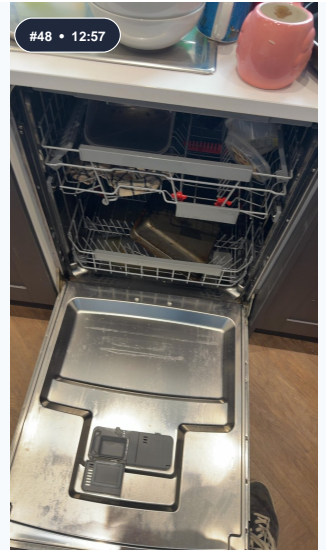
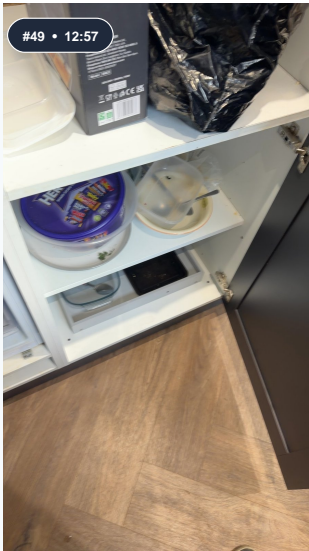
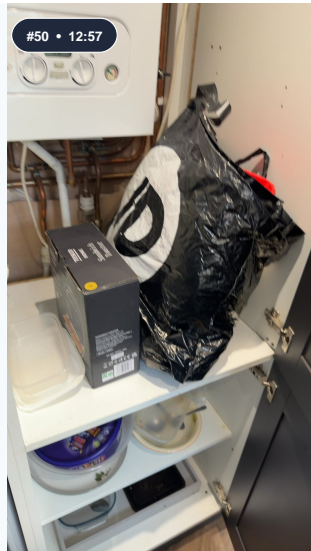
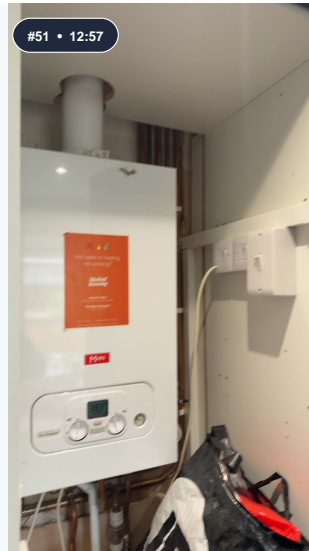
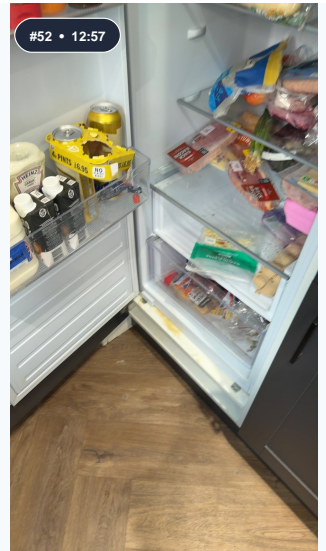
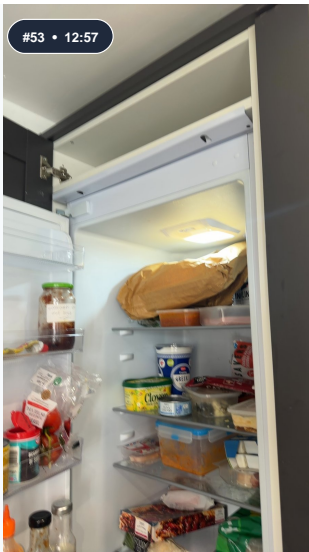
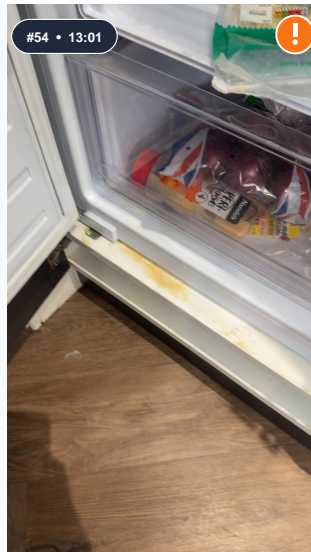
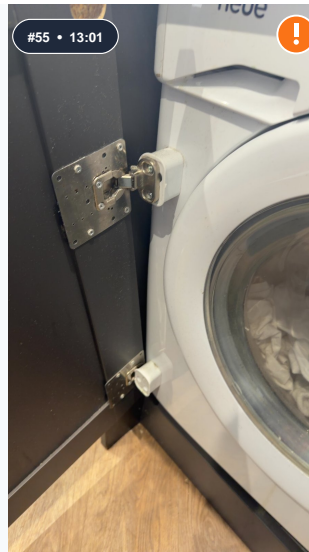
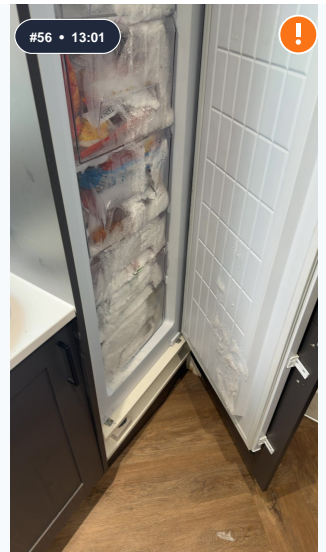
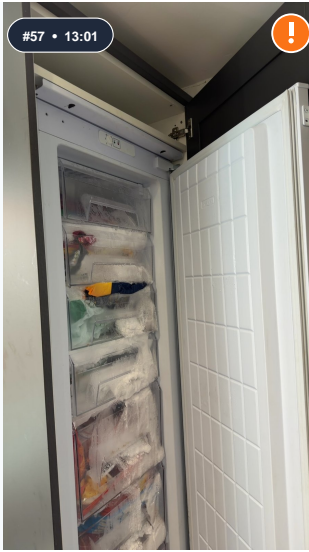
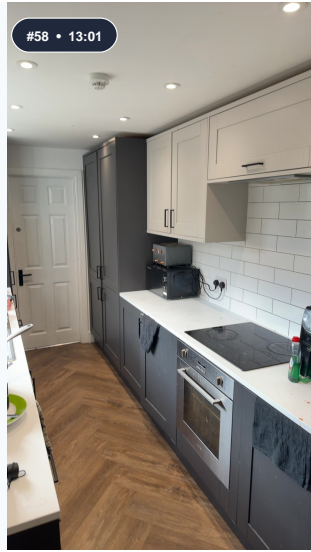
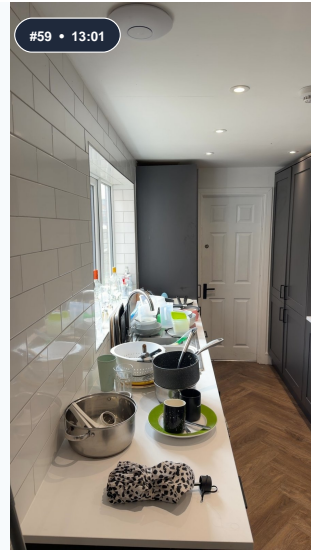
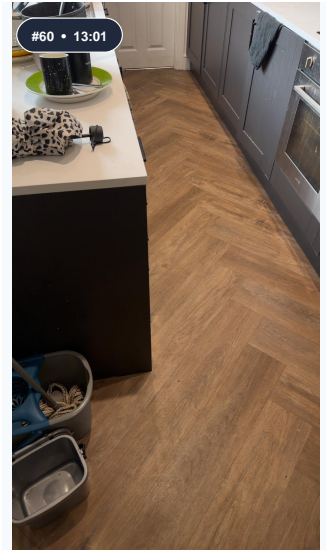
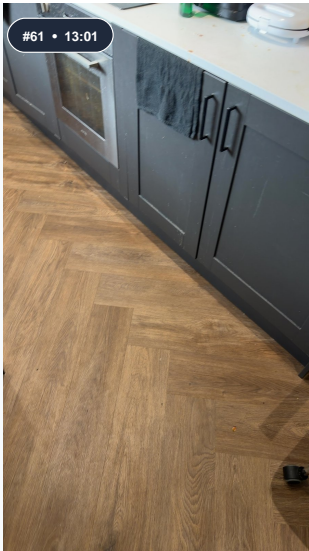
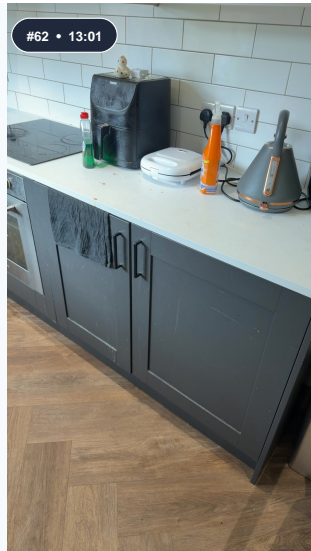
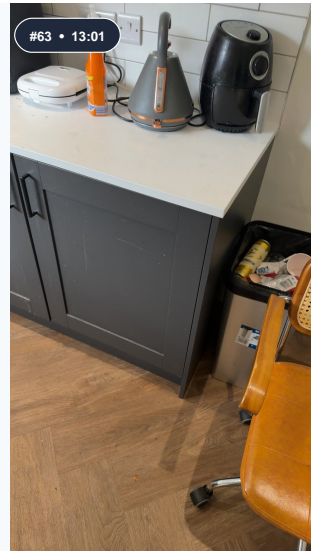
# Kitchen

The kitchen exhibited an unsatisfactory level of cleanliness, with accumulated debris and residue present. The dishwasher appeared functional, closing correctly upon inspection despite tenant concerns. Several appliances, including the freezer which requires defrosting, were observed to be uncleaned.

Poor Condition

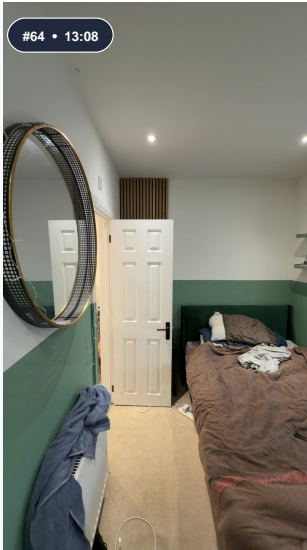
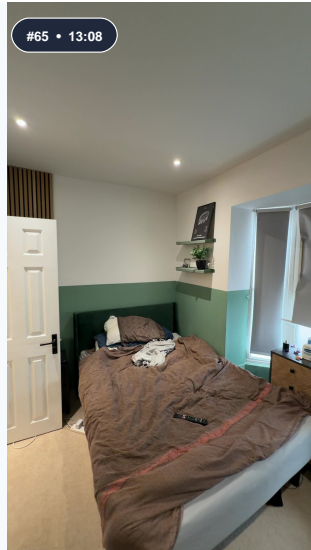
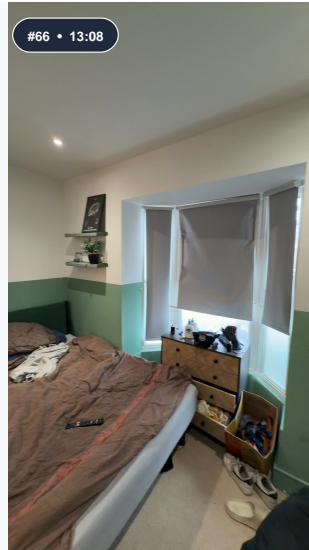
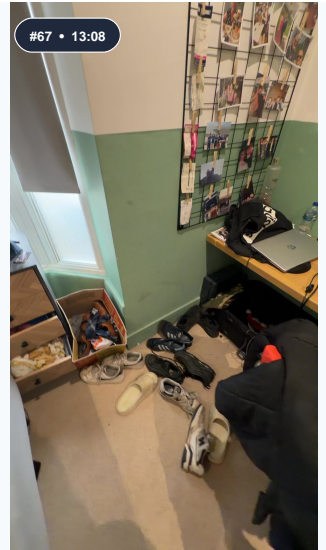
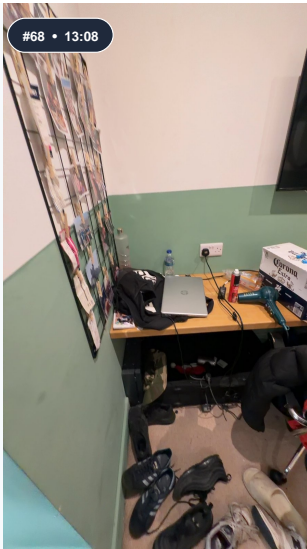
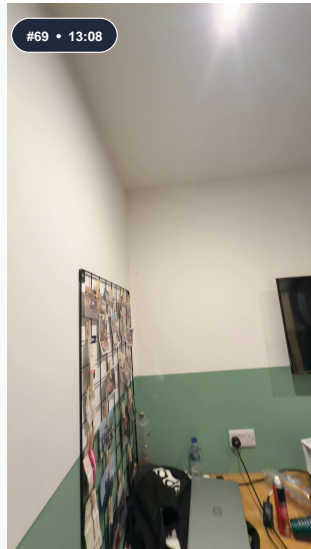
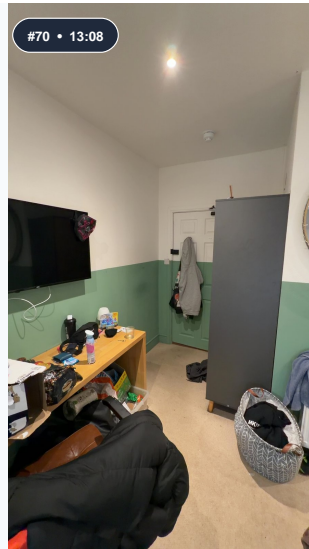
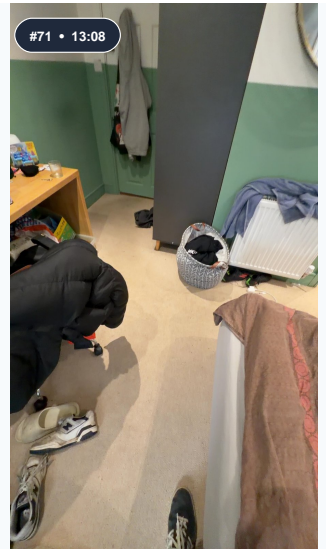
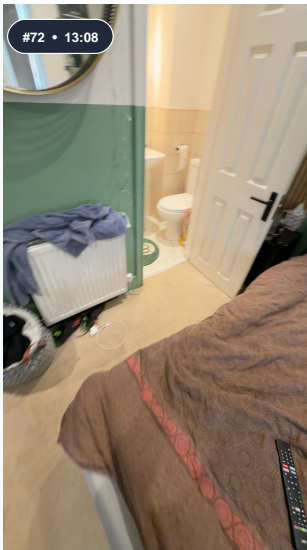
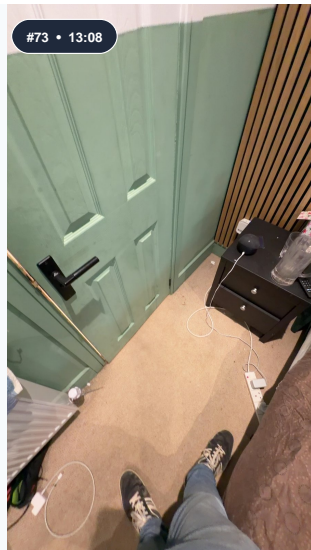
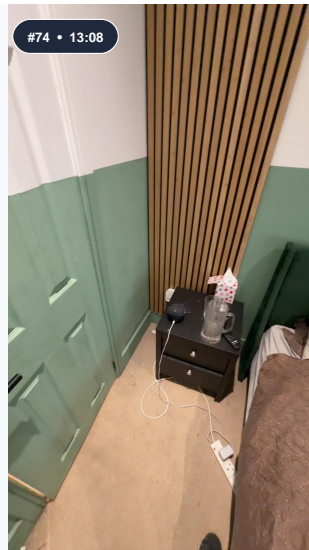
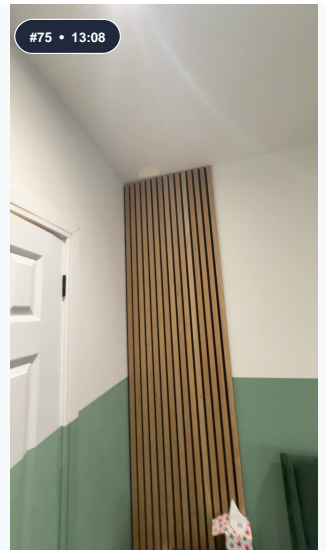
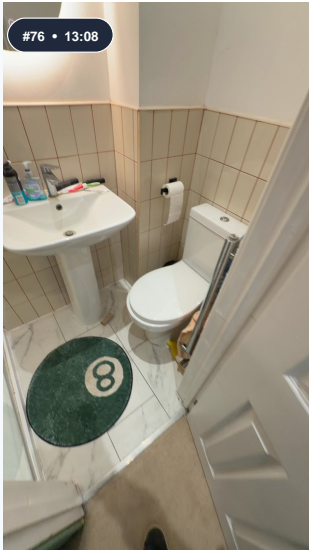
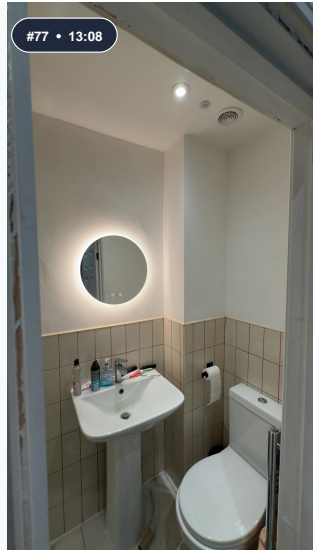
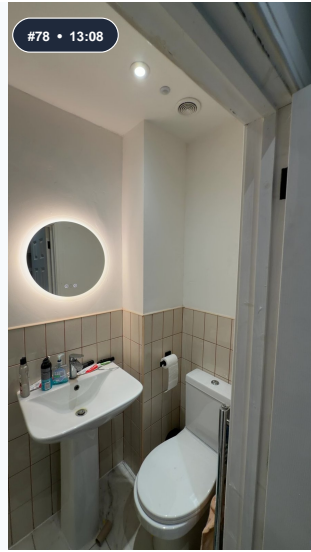
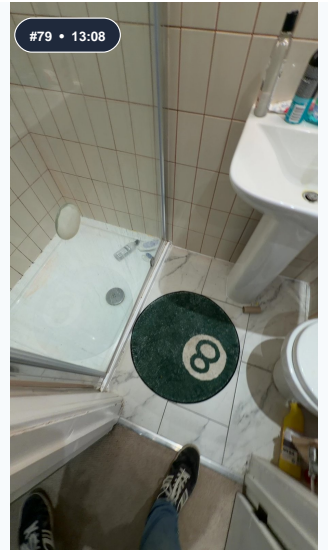
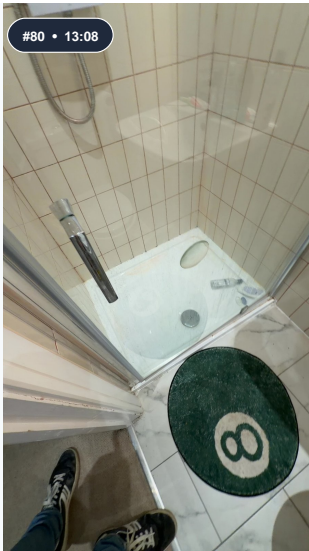
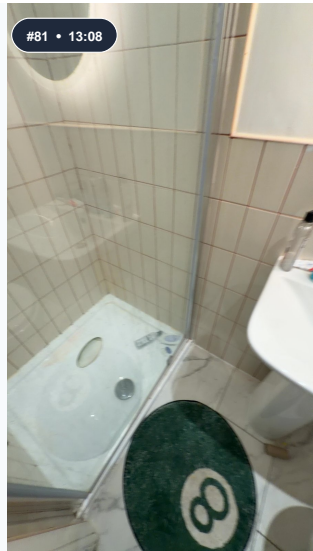
# Bedroom 1

The overall condition of Bedroom 1 is fair. The room is generally presentable, though some surfaces would benefit from cleaning.

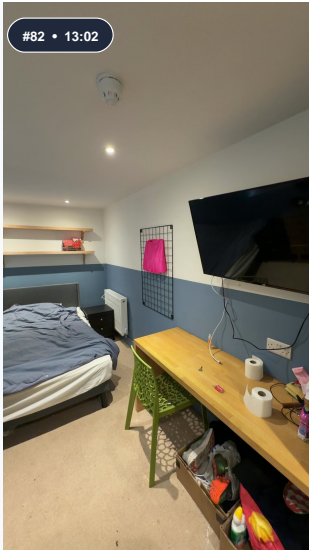
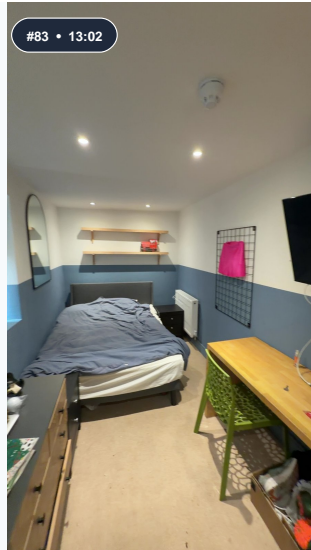
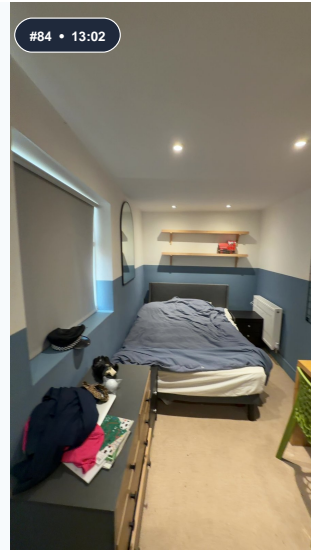
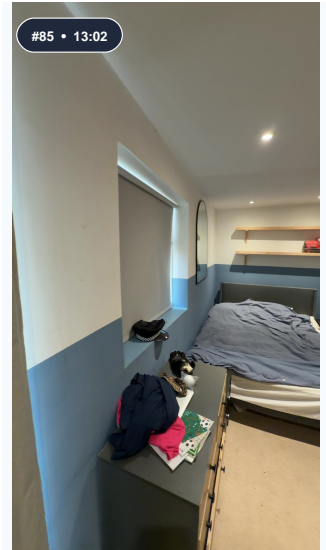
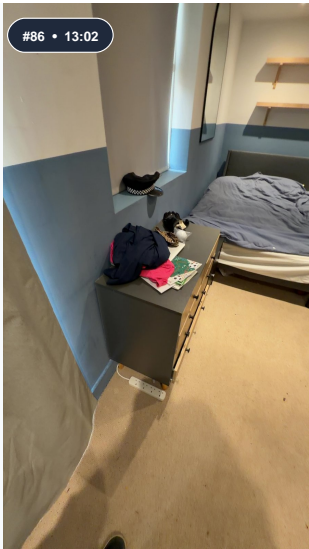
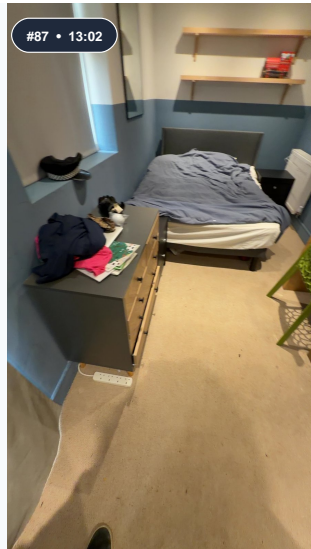
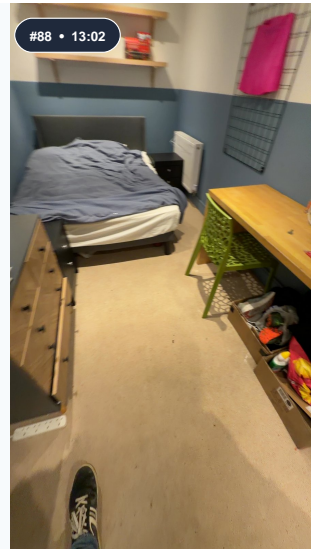
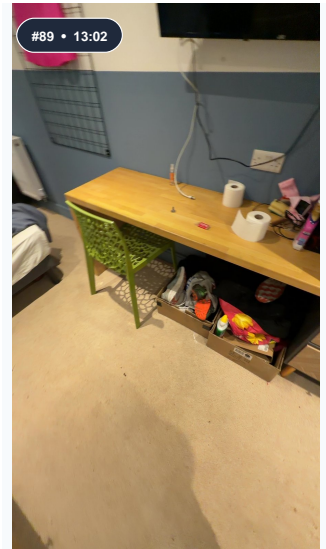
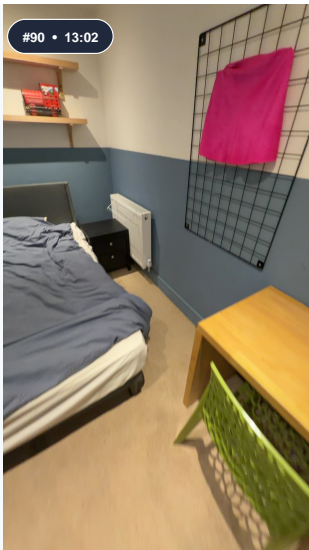
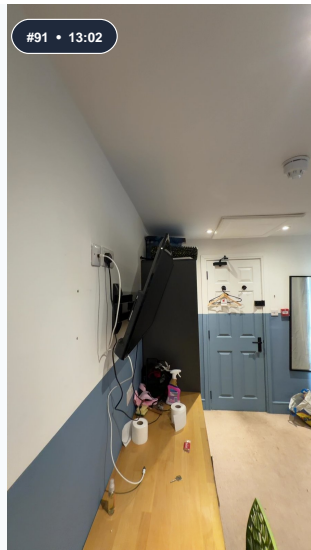
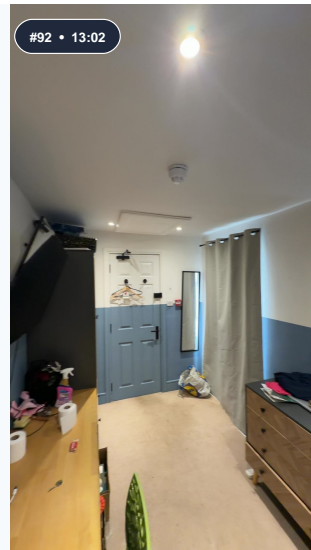
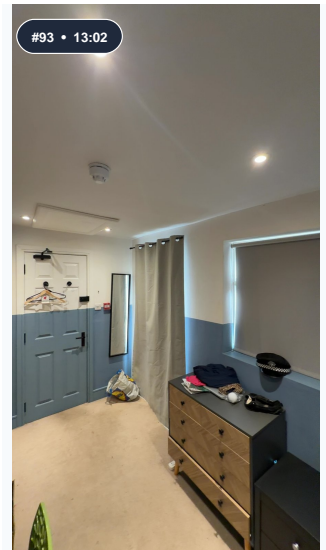
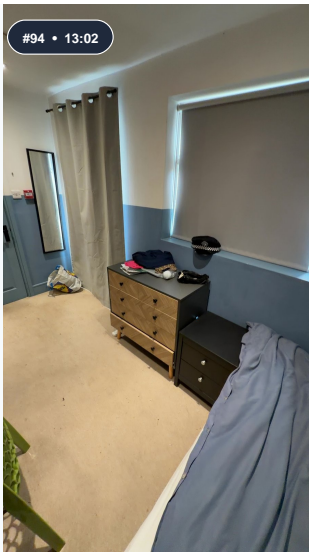
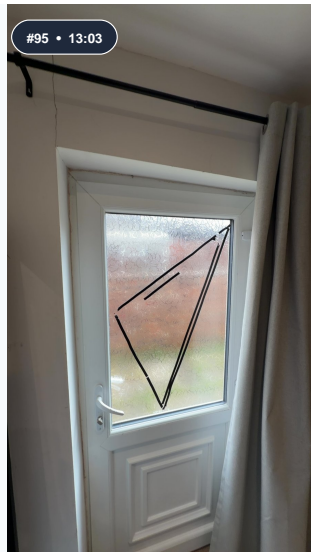
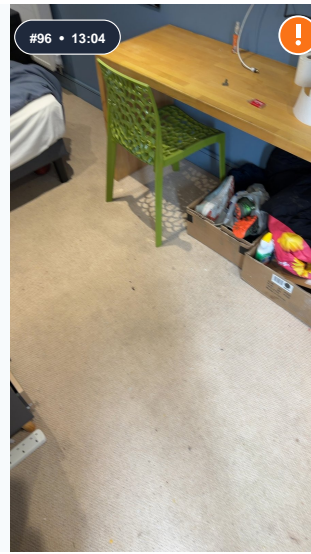
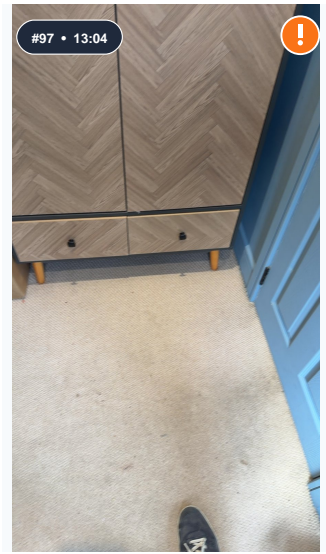
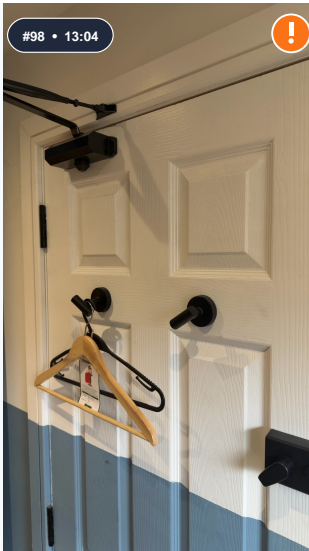
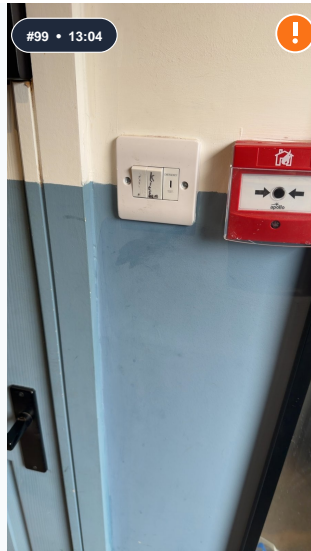
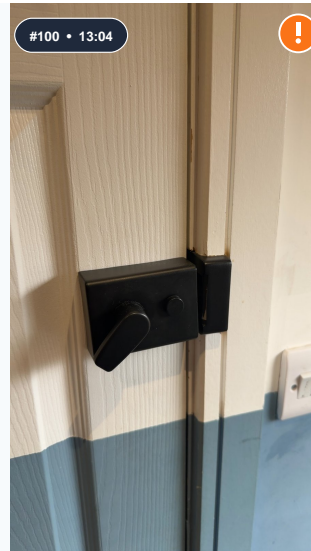
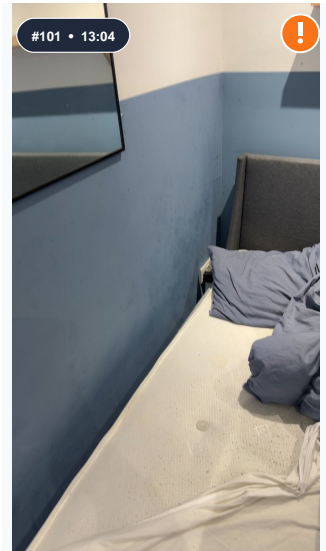
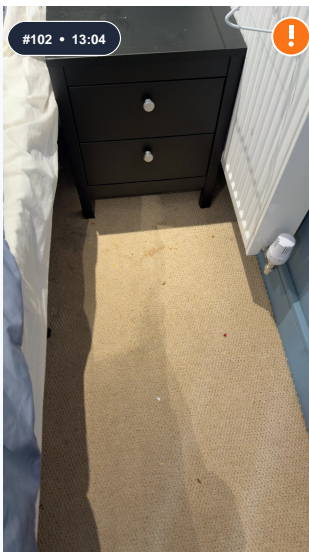
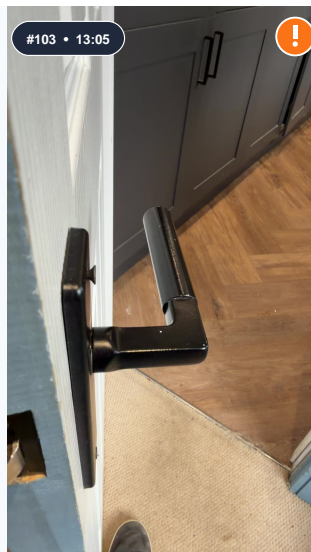
# Bedroom 2

The overall condition of Bedroom 2 is satisfactory. However, the carpets in this room exhibit numerous marks and staining, and the wall surfaces show significant signs of marking and scuffing throughout.

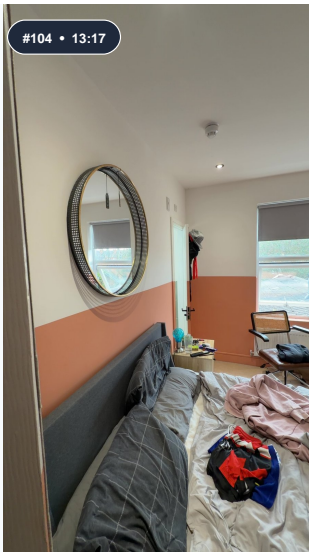
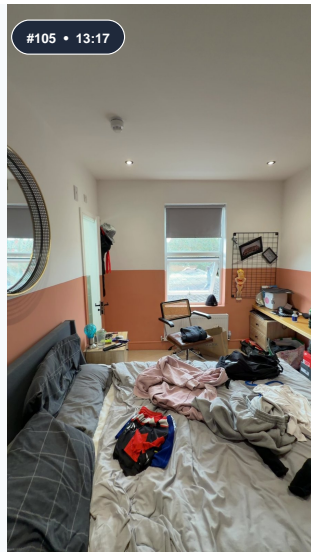
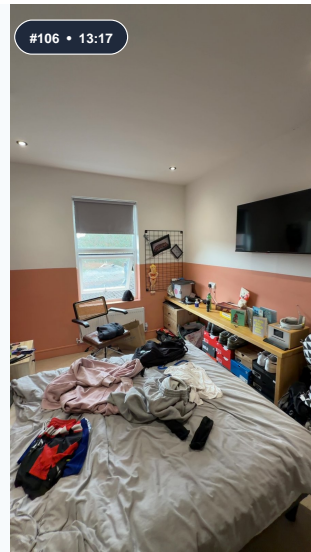
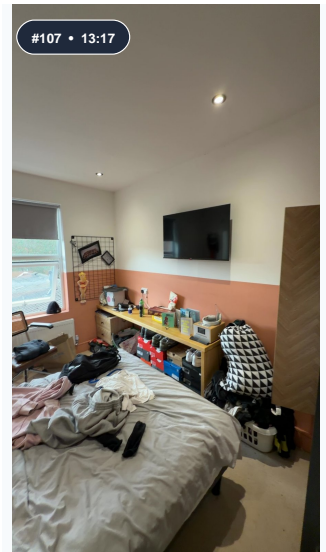
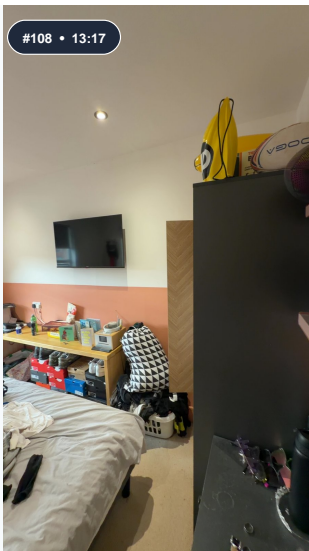
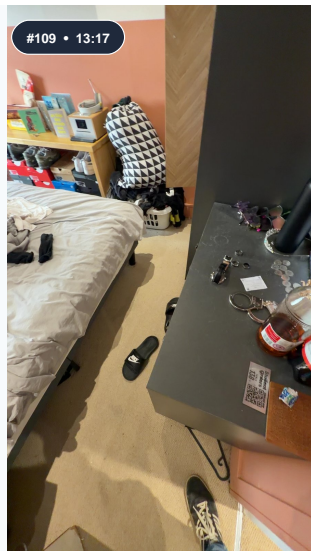
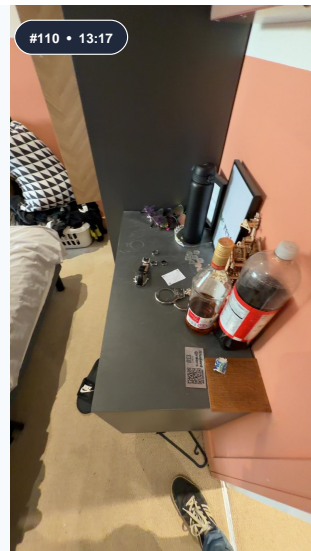
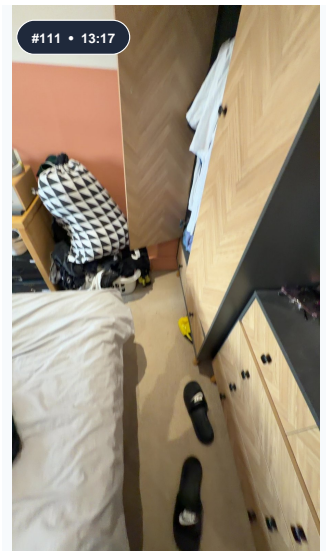
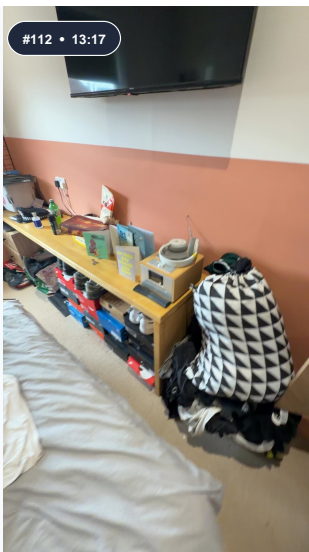
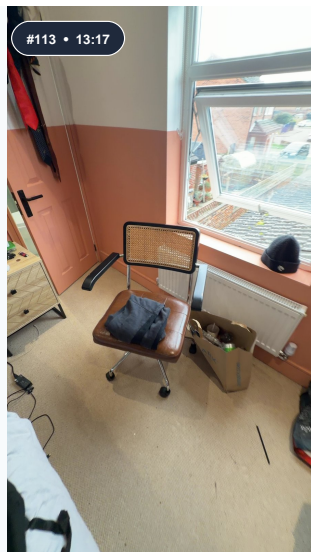
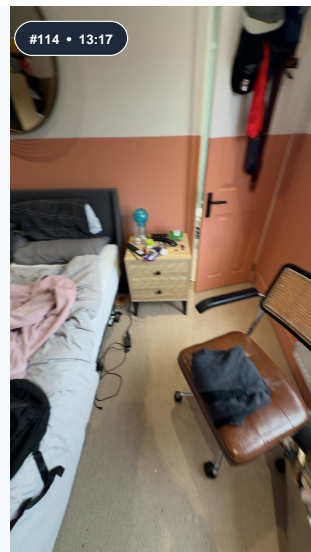
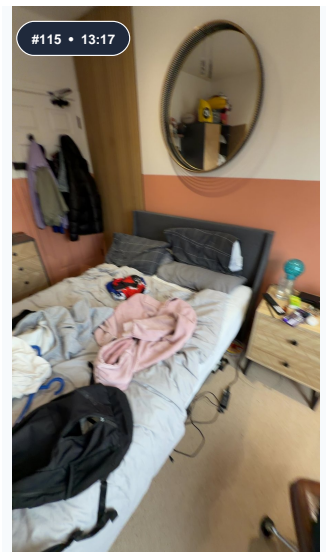
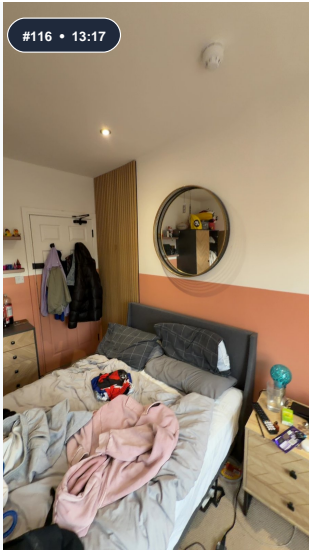
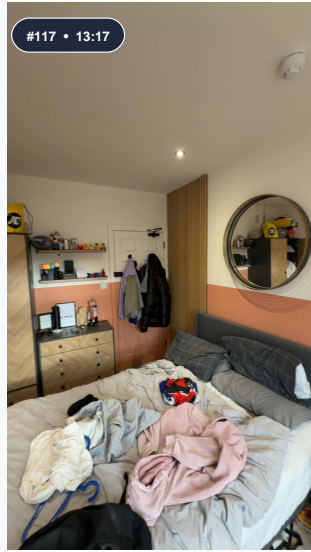
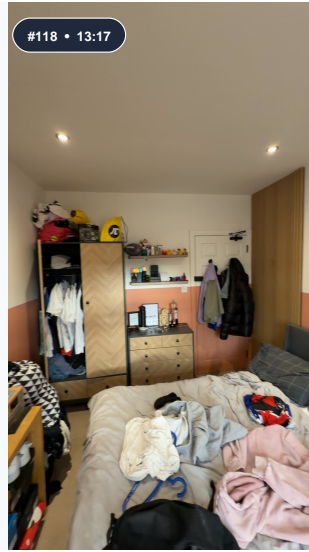
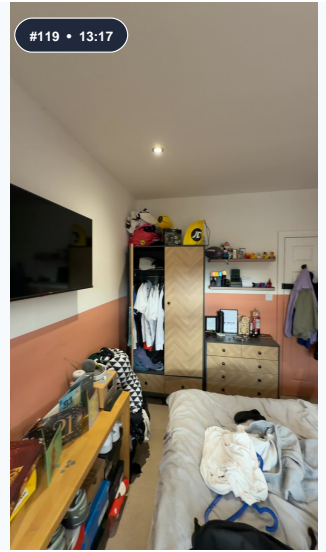
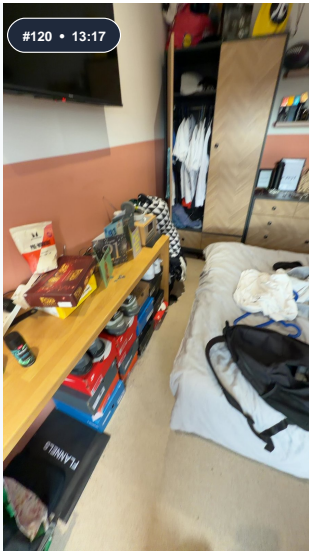
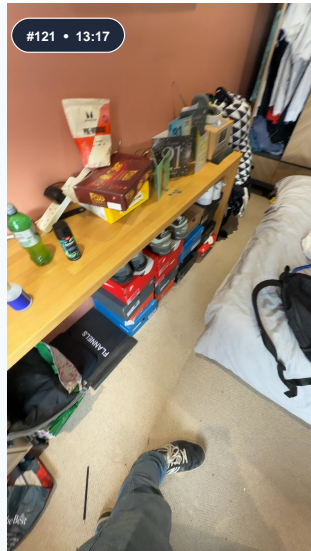
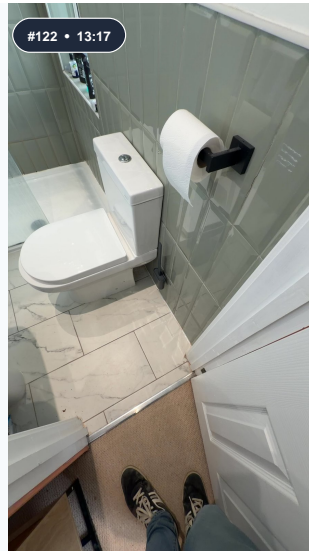
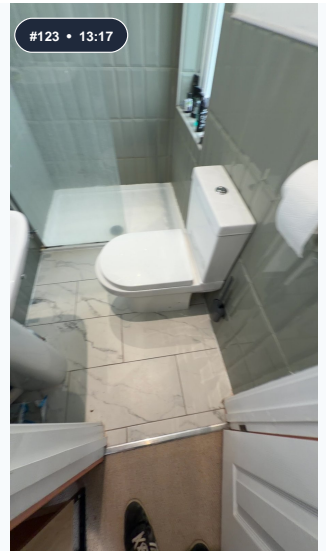
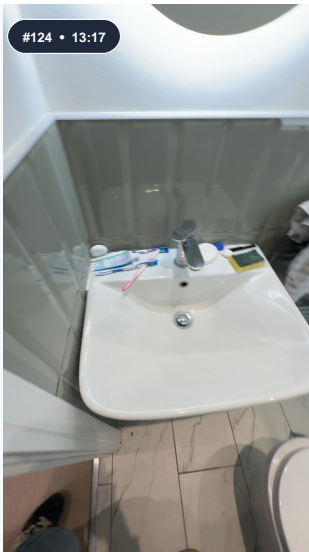
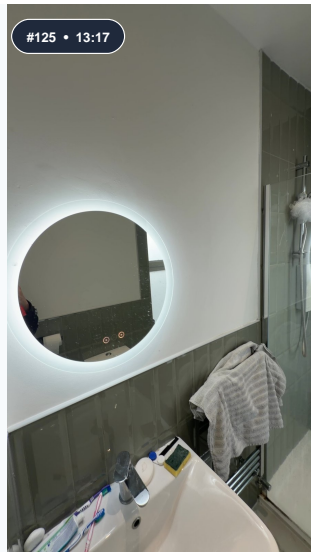
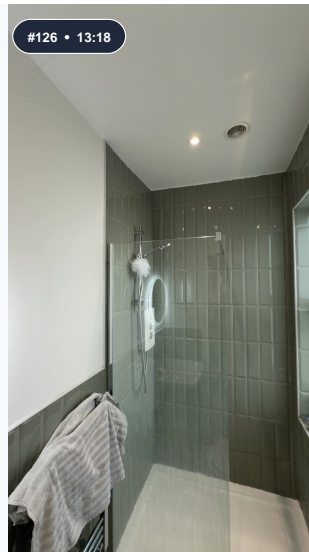
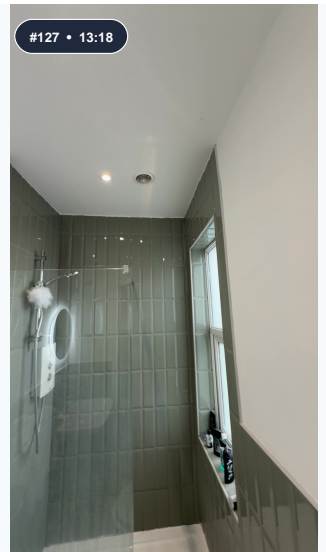
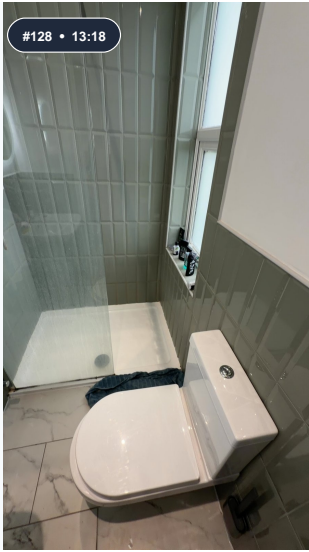
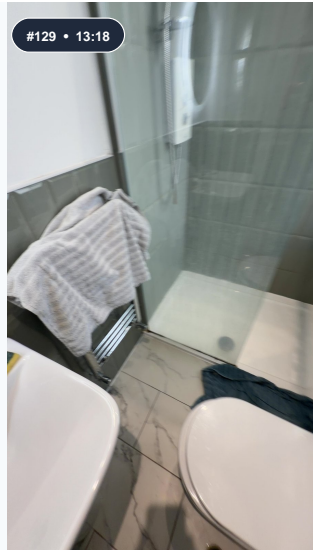
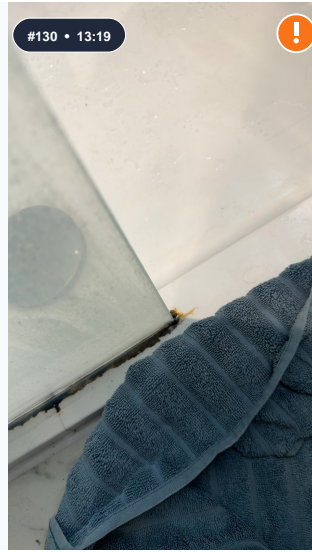
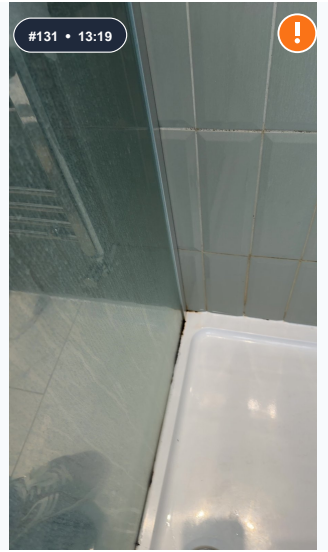
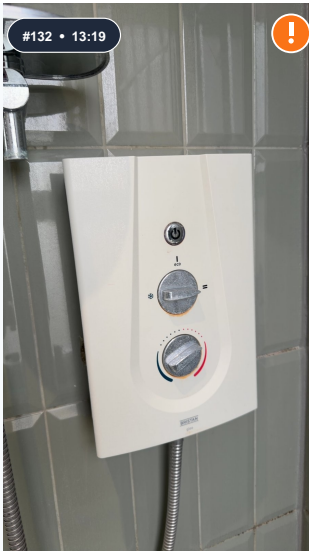
# Bedroom 3

Bedroom 3 is in fair condition with observed wear consistent for its age and use. The attached bathroom requires deep cleaning to improve its overall appearance and sanitation.

Fair Condition

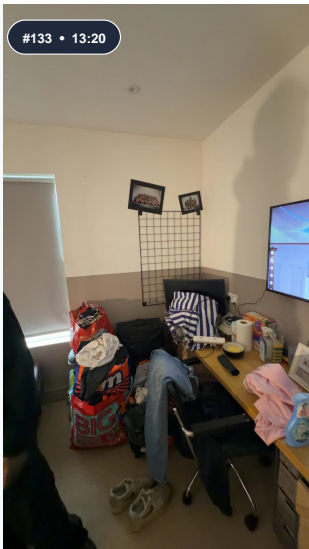
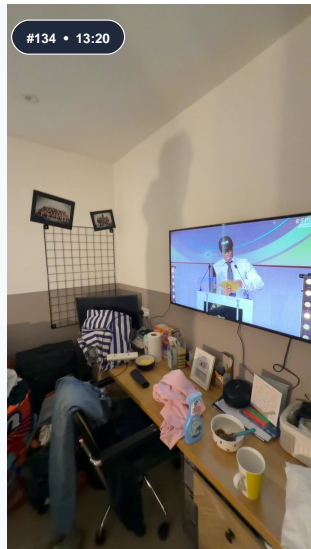
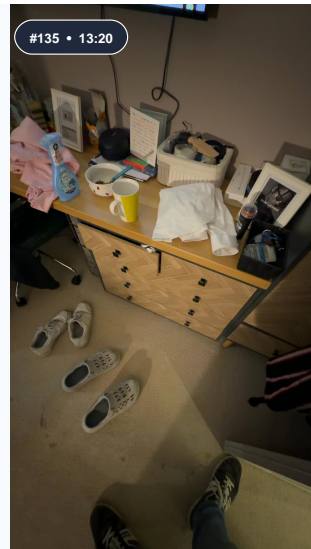
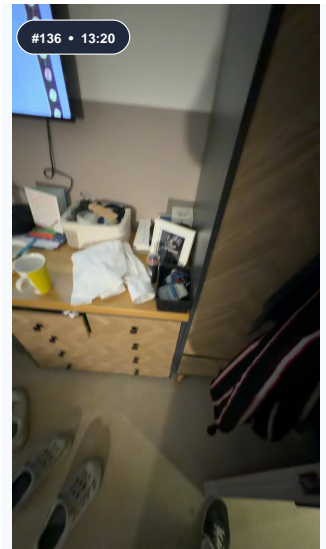
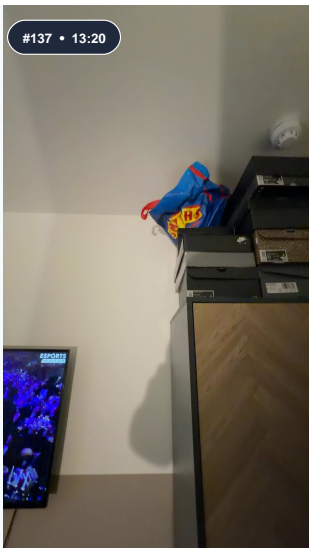
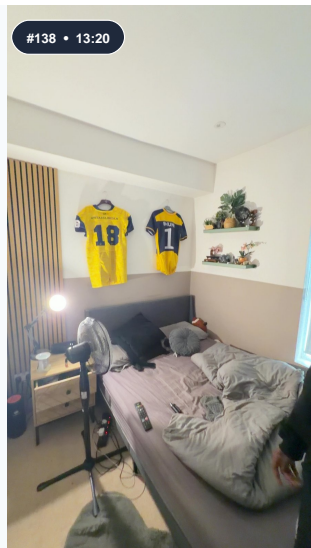
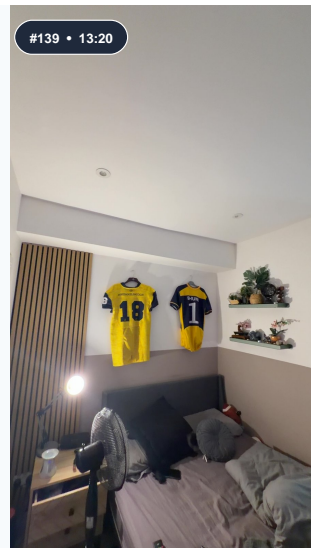
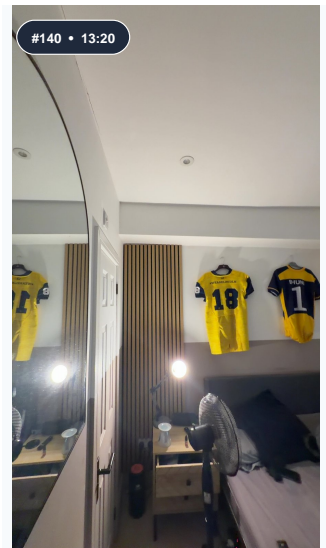
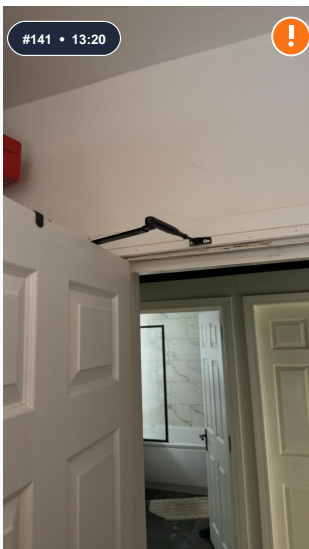
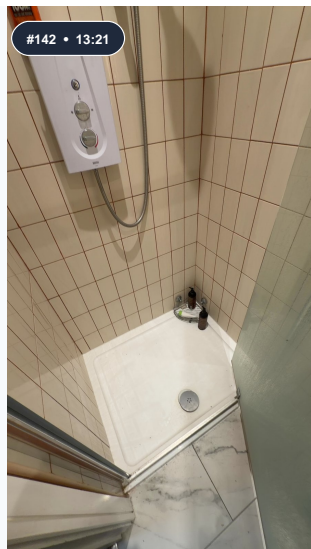
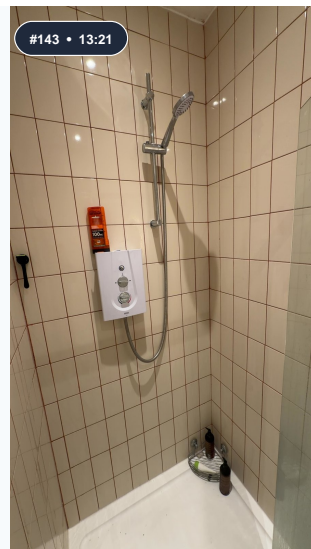
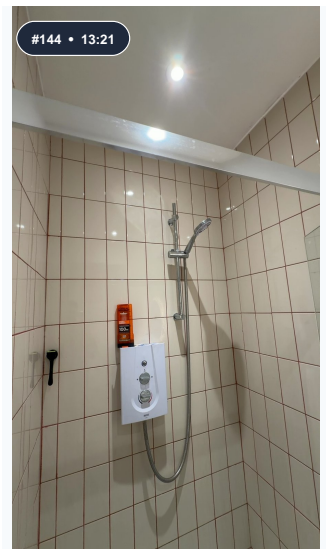
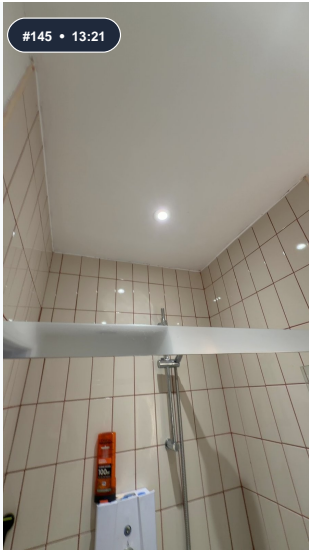
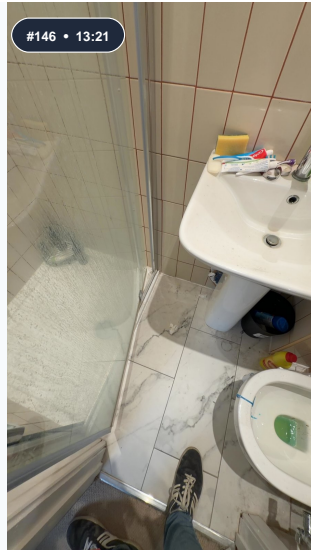
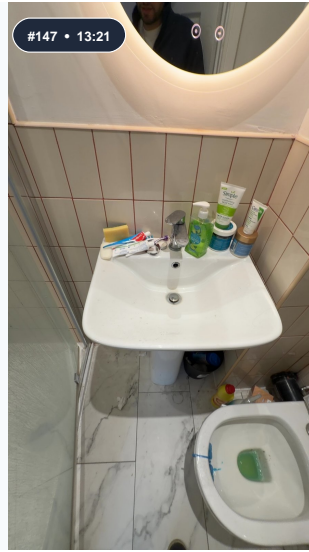
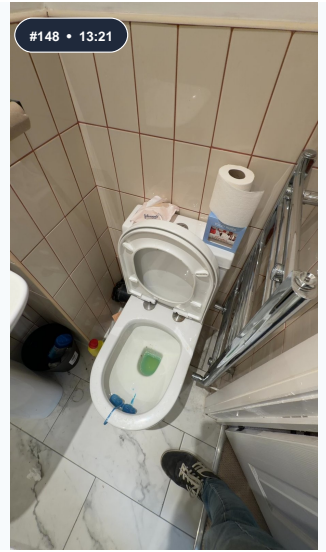
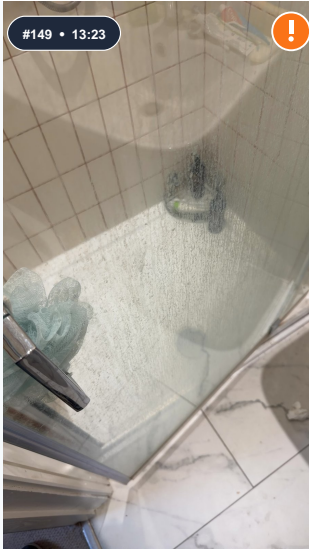
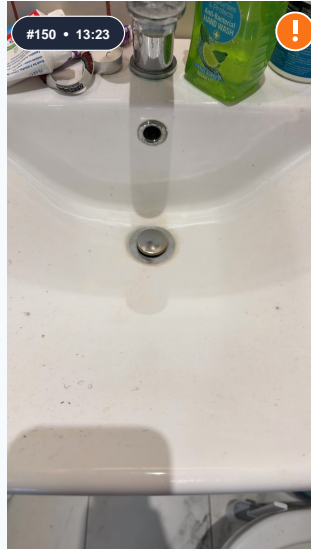
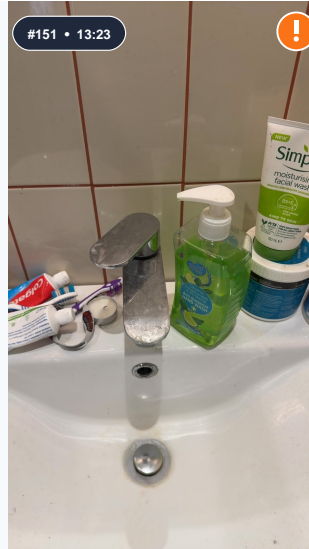
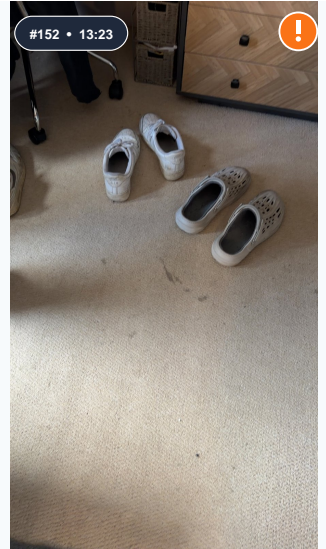
# Bedroom 4

The overall cleanliness of Bedroom 4 is fair, primarily due to the presence of dirt and clutter. Prior to occupancy, it is recommended that the room undergo a professional cleaning service and be cleared of all personal belongings.

Fair Condition

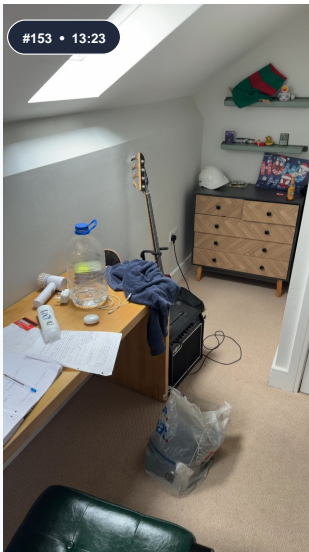
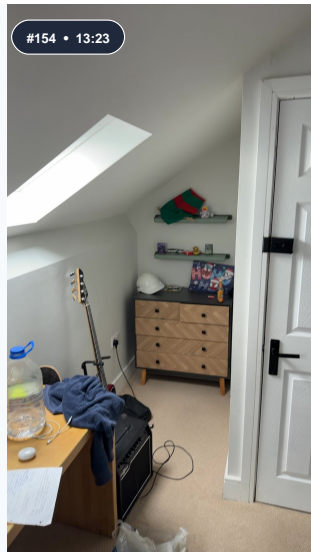
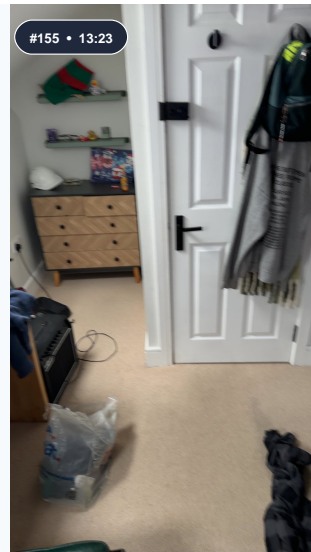
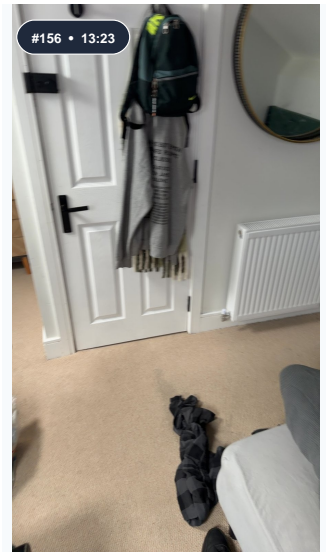
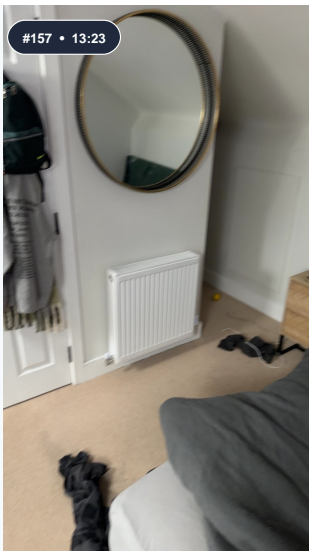
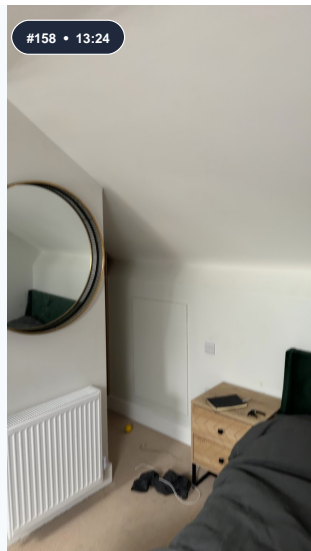
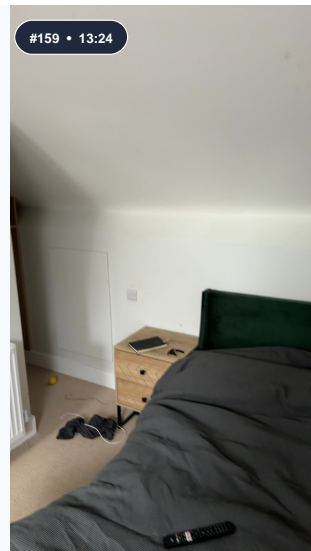
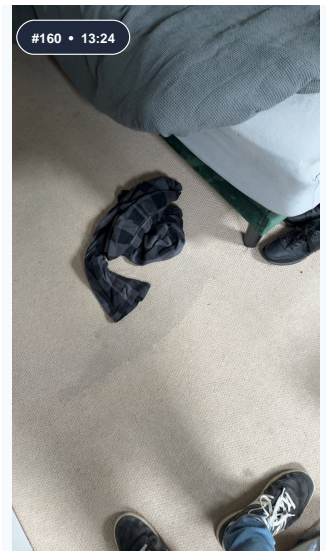
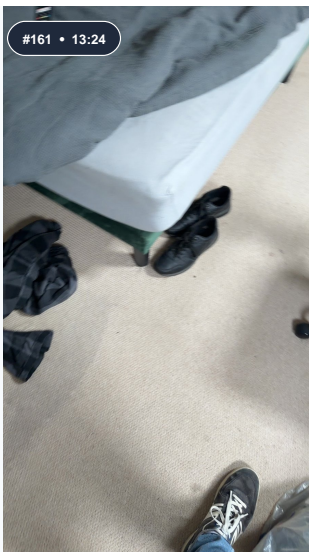
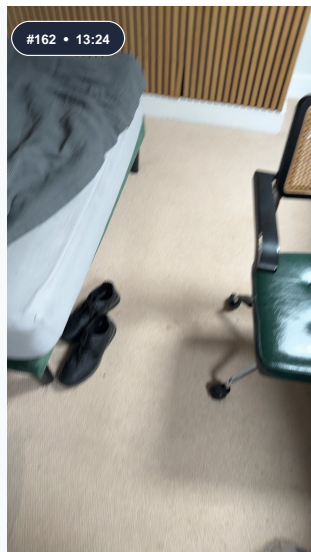
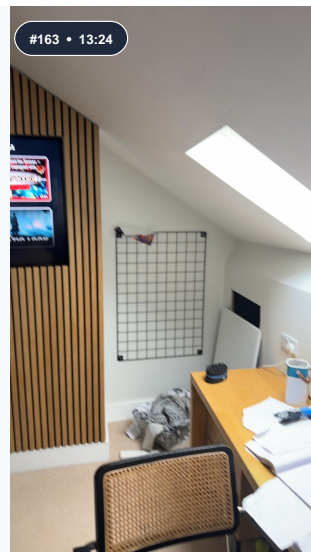
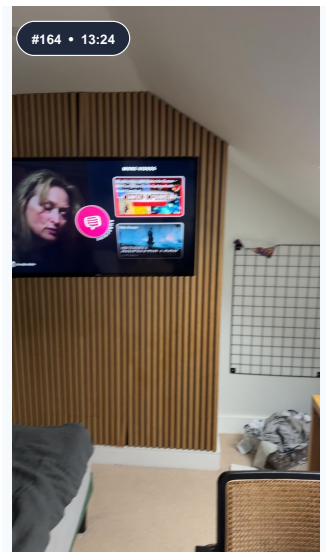
# Bedroom 5

Fair Condition
