# PROPERTY INSPECTION REPORT

*Student  
Housing*

**20 Sewells Walk**

**Friday, 13 March 2026**

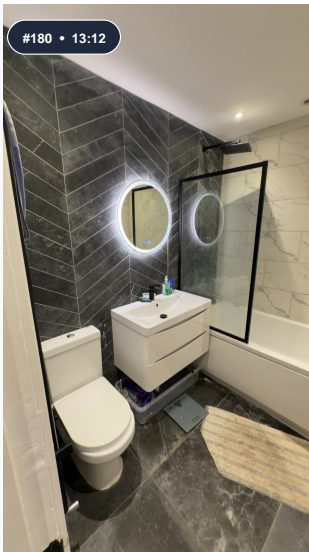
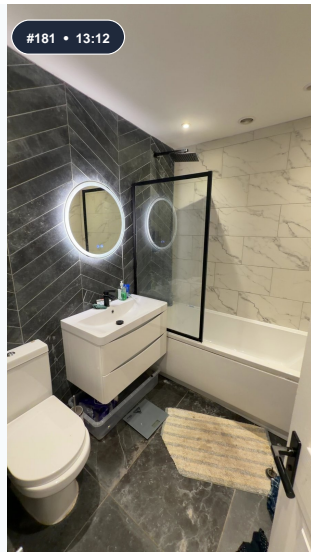
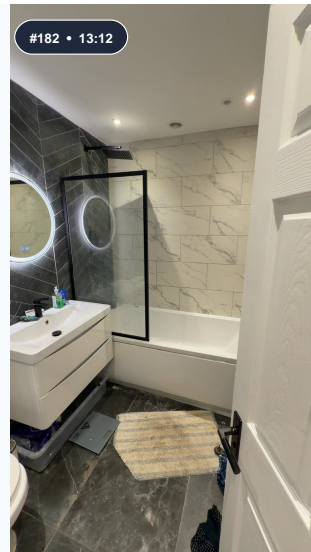
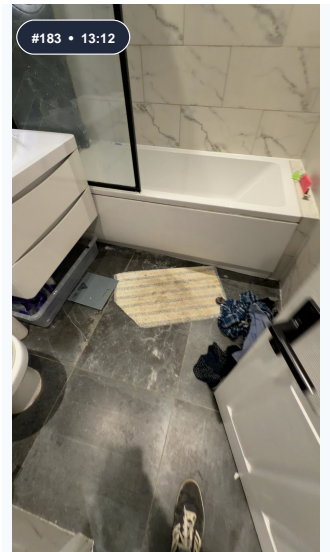
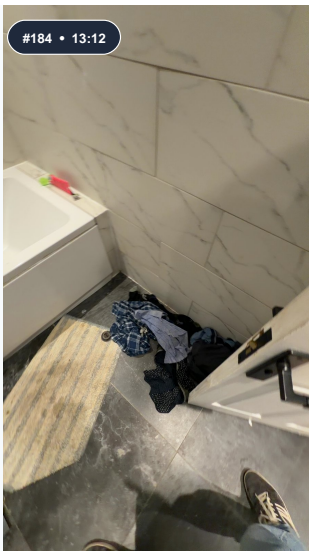
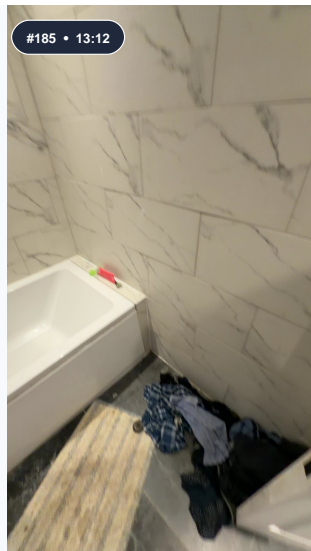
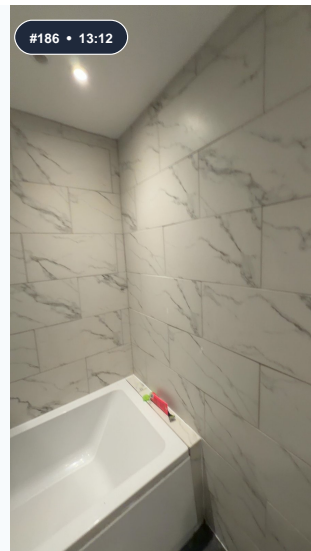
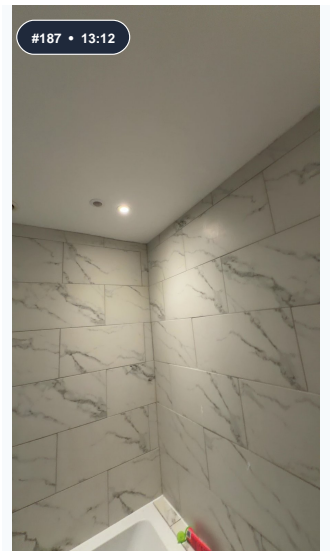
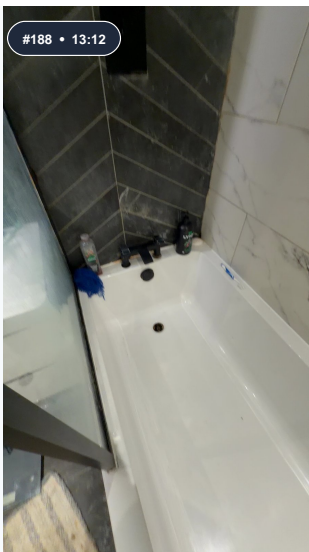
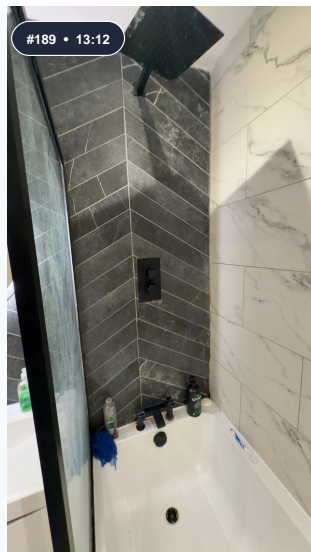
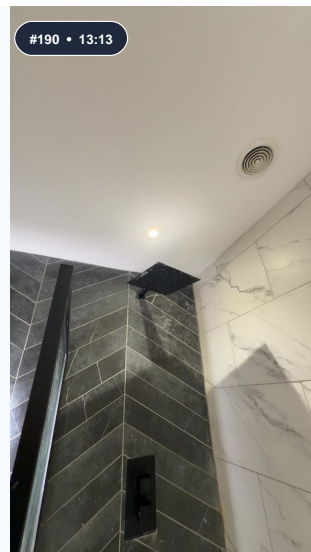
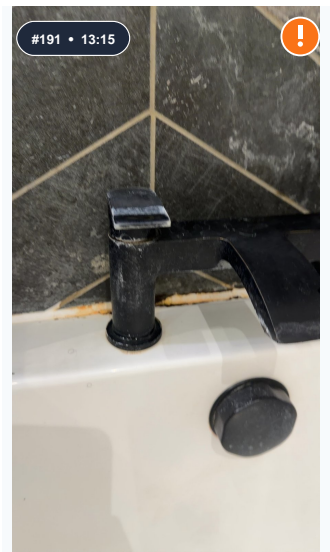
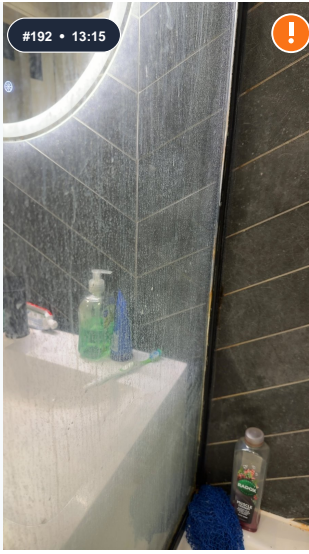
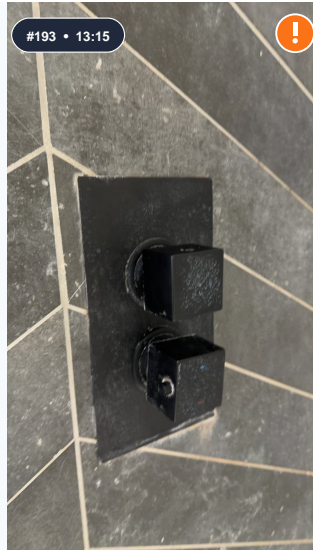
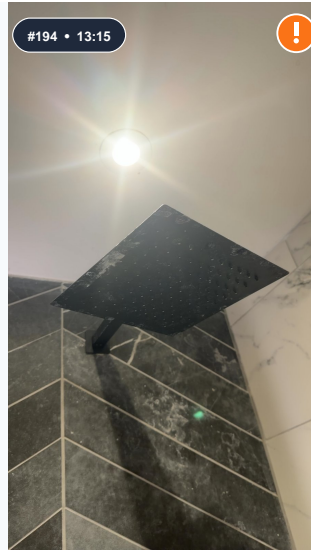
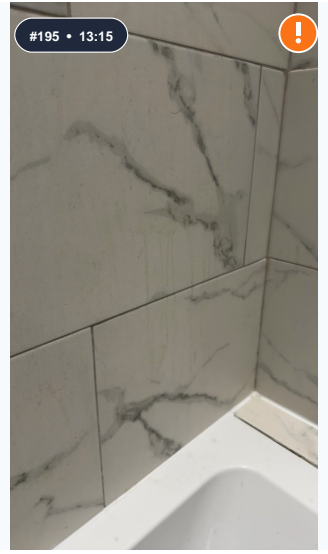
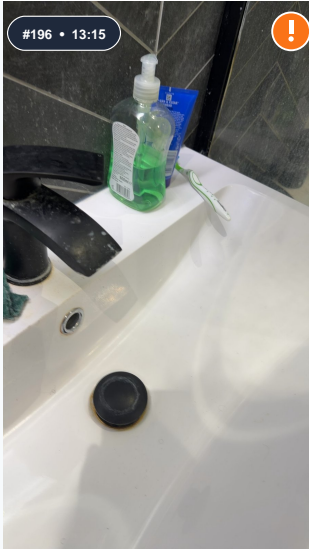
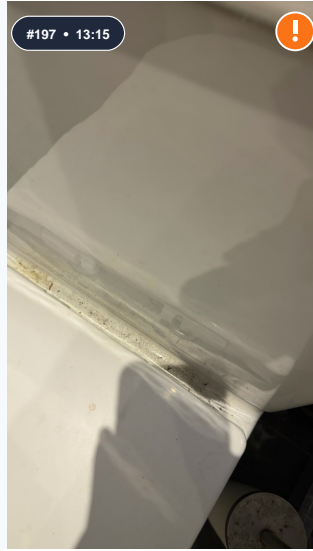
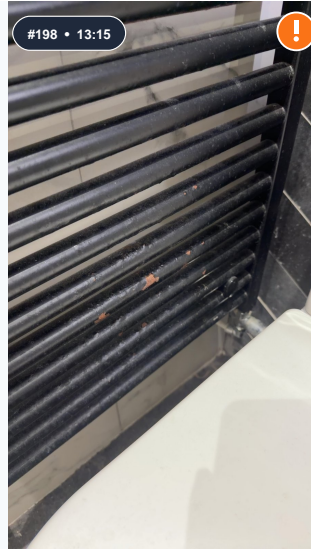
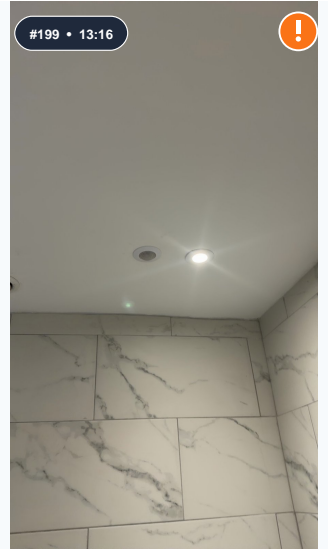
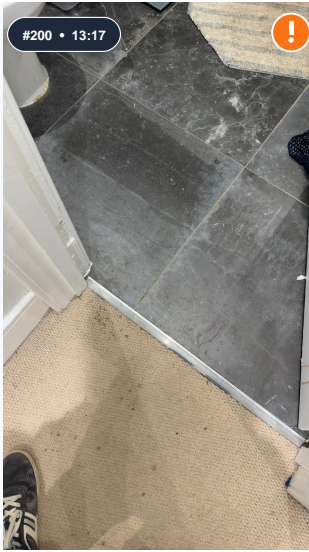
# Bathroom 1

Bathroom 1 is in poor condition. The room exhibits a significant accumulation of dirt and debris. This level of uncleanliness may have resulted in permanent damage to some of the fixtures and surfaces within the room.

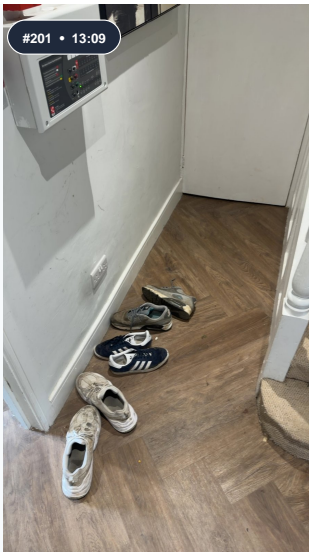
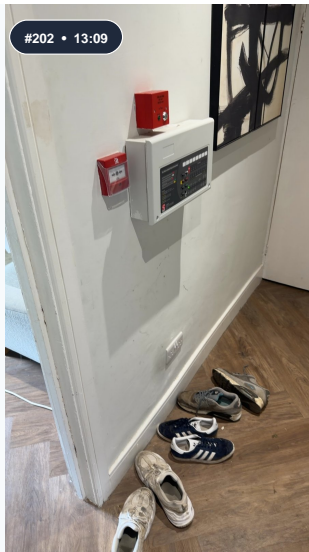
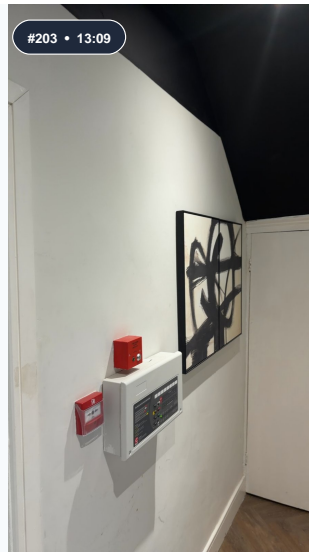
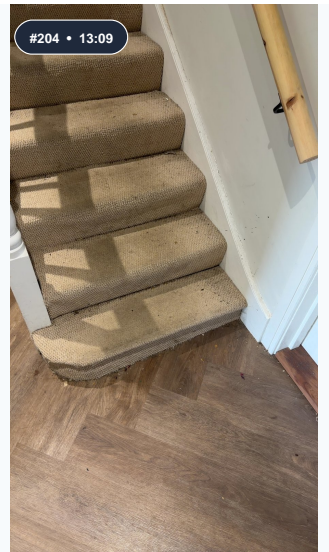
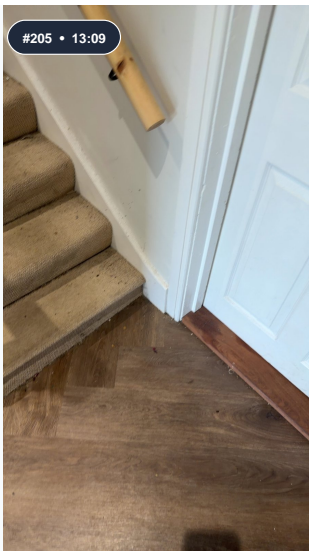
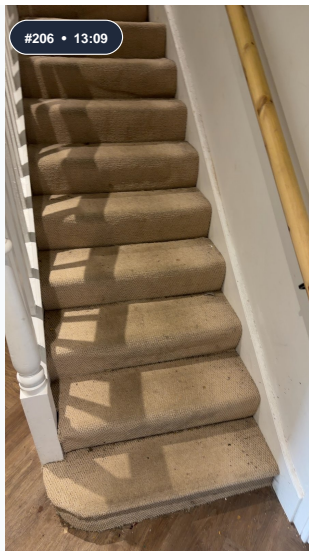
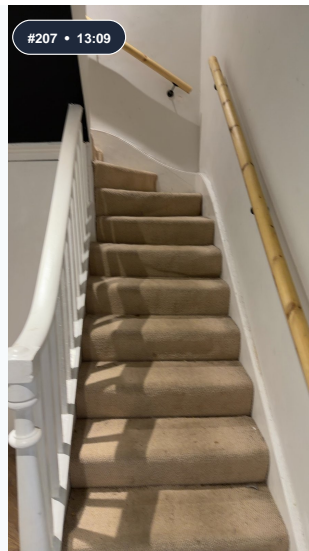
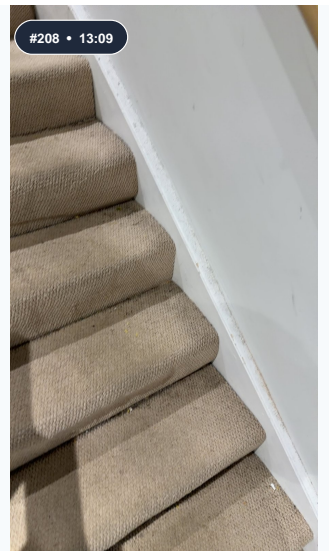
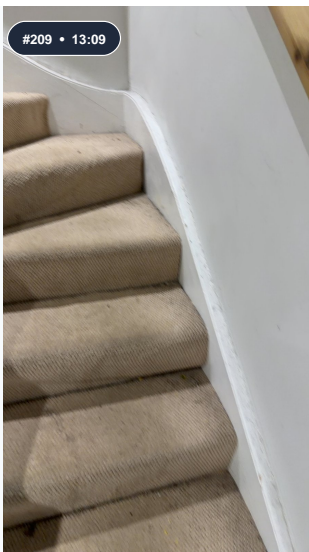
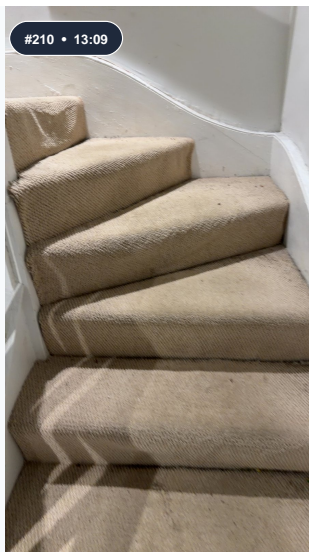
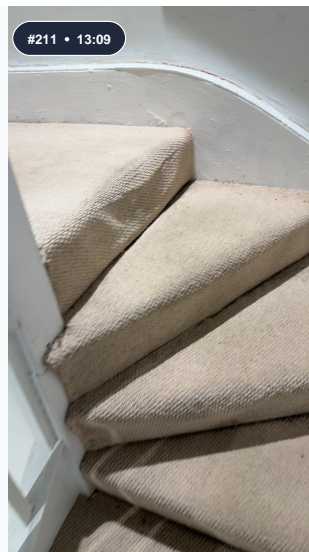
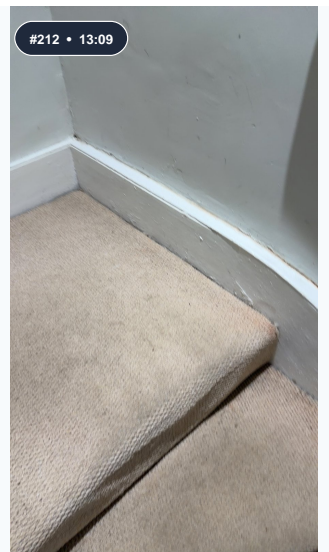
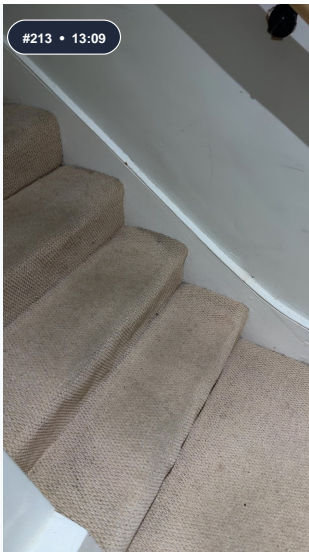
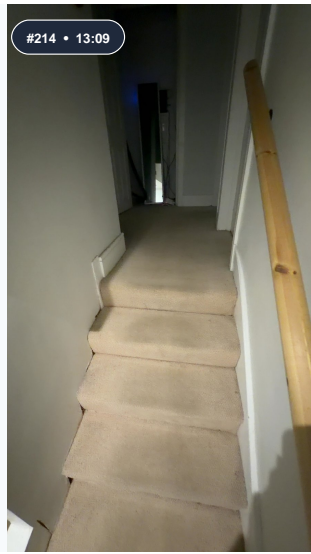
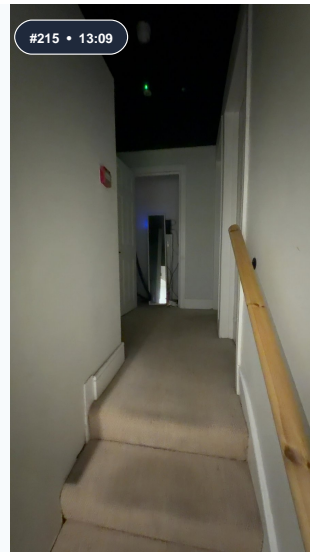
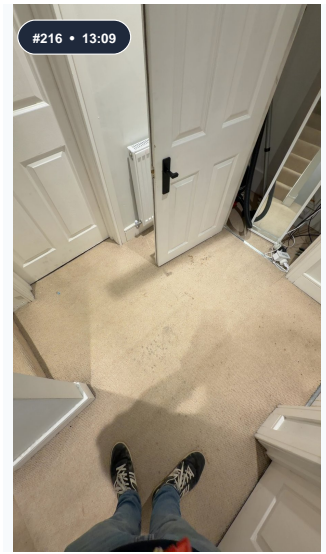
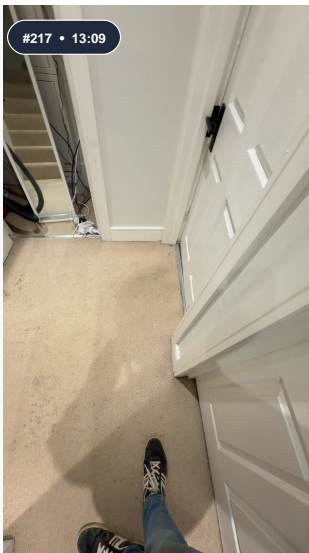
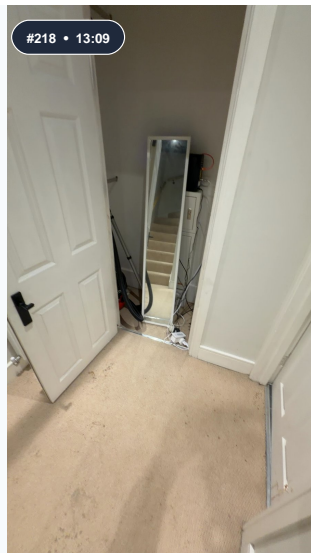
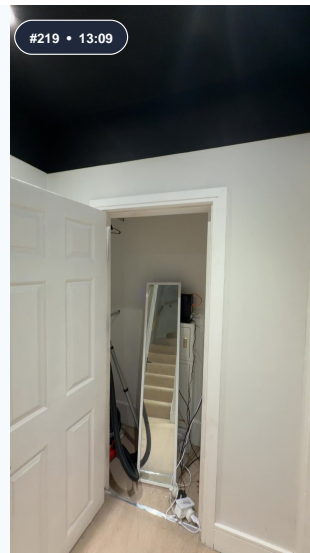
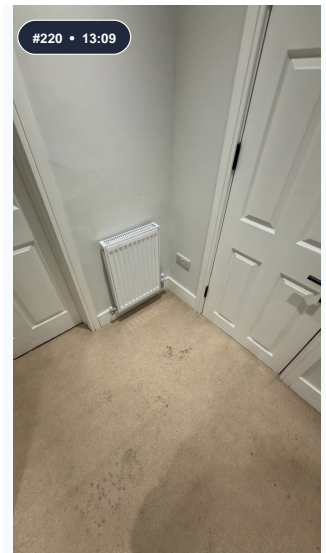
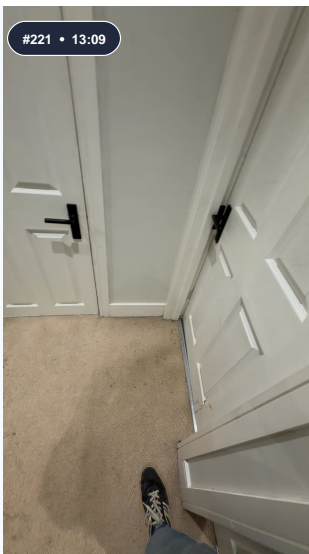
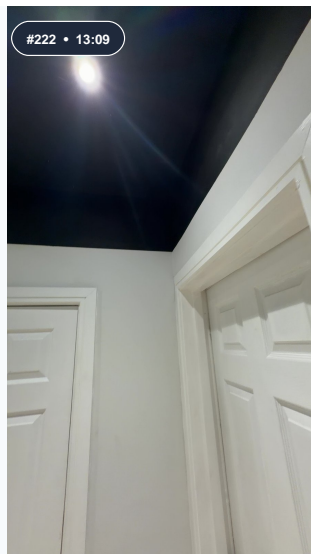
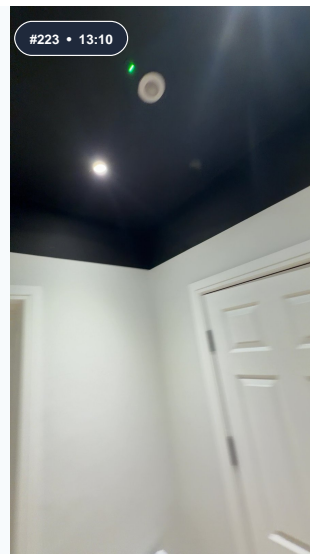
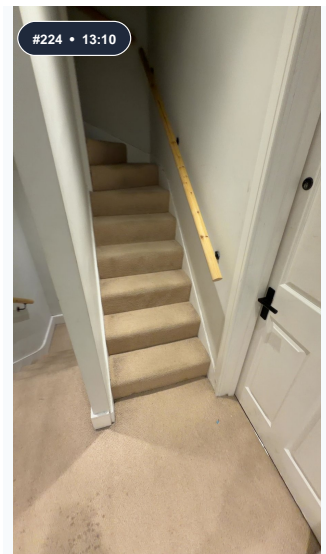
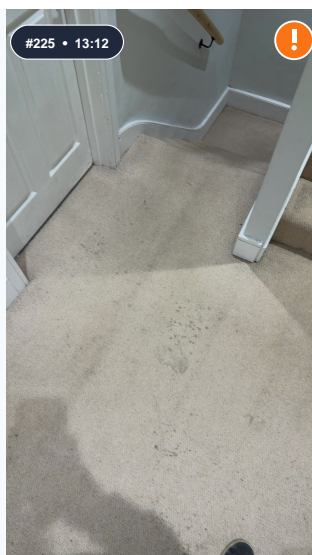
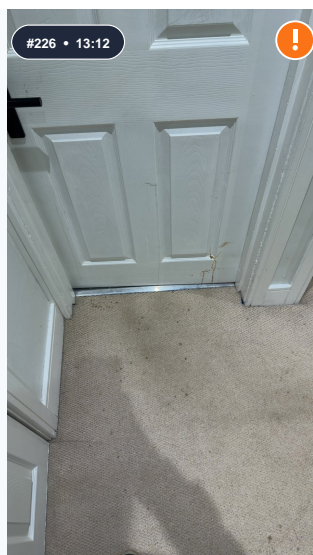
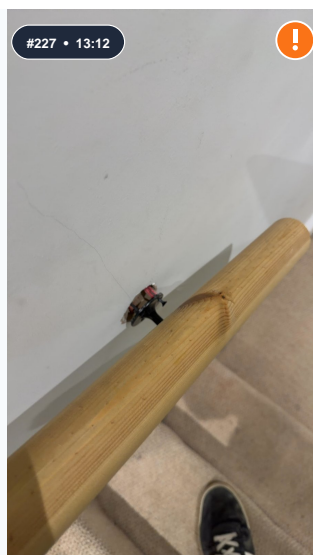
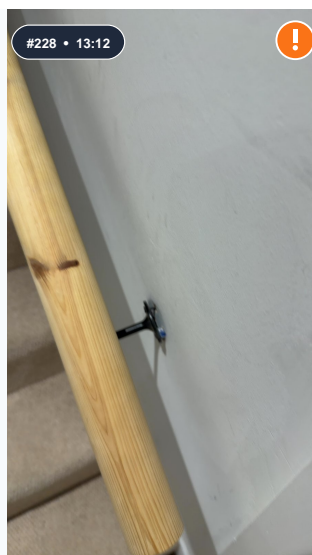
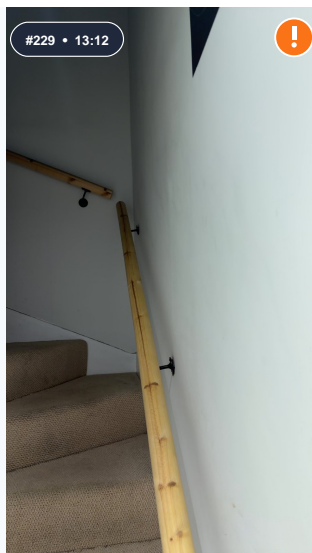
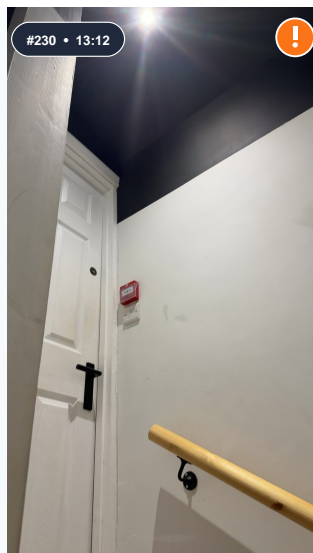
# Hallway

The hallway exhibits substantial deterioration, requiring comprehensive cleaning and significant repairs. The overall condition is considered very poor.

Very Poor Condition
